## **Level 1 Geotechnical Testing and Inspection Authority Services**

**Riverfield Estate Stage 7, Lots 701 to 745  
Clyde**

**19 January 2023**

**Our Ref: 1016363.007.v1**

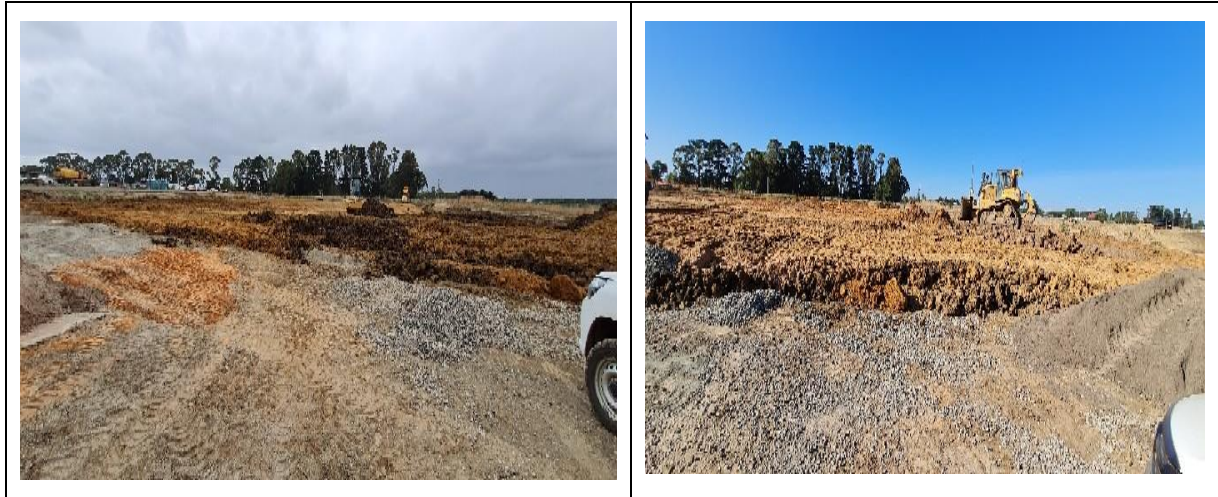
Photograph 2.7.1:

**Figure 1.** Photograph of the material used on site

General Site Photo
