REPORT

Level 1 Geotechnical Testing and Inspection Authority Services

**Riverfield Estate Stage 8, Lots 801 to 856
Clyde**

23 February 2023
Our Ref: 1016363.008.v1

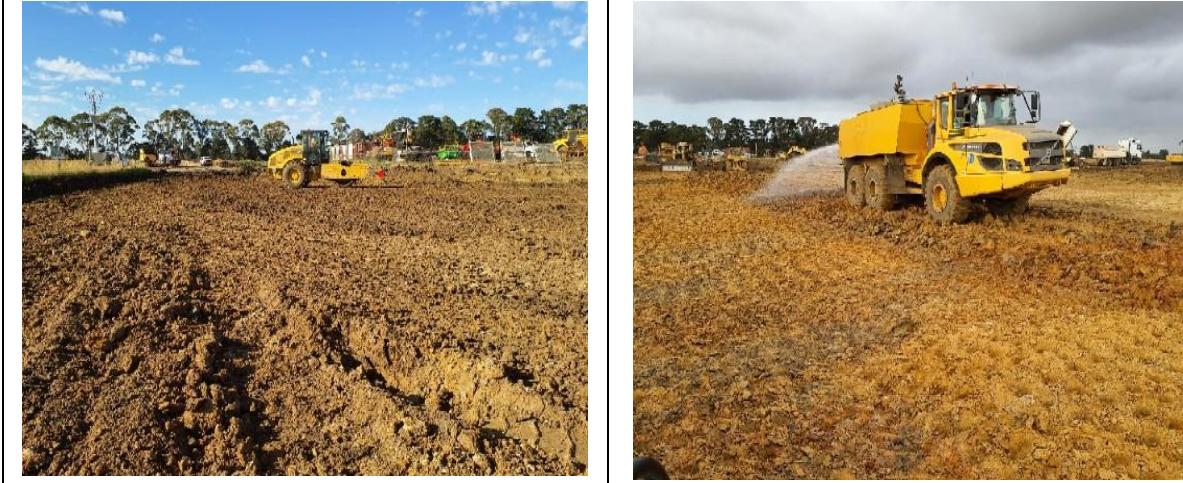
Photograph 2.7.1:

Figure 1. Photograph of the machinery and material used on site

Compaction of clay
