## **Level 1 Geotechnical Testing and Inspection Authority Services**

**Riverfield Estate Stage 10**

**Lots 1001 and 1031**

Our Ref: 1016363.010.v1

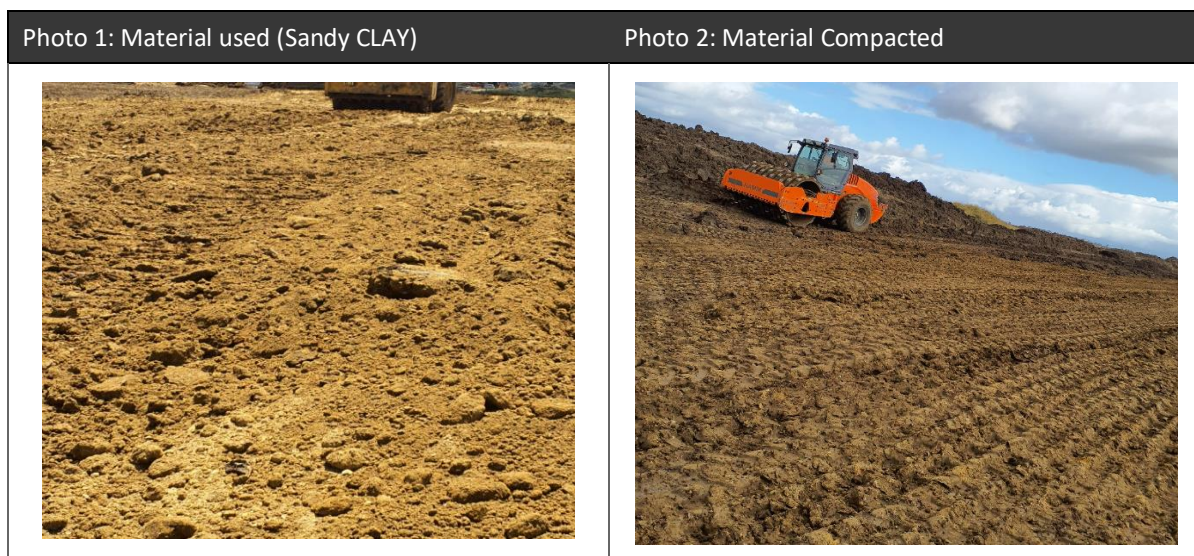
*Figure 3.1: Photographs of the material used on site*

Any observed organic or deleterious matter including any oversize cobbles or boulders were removed from the tested areas during the fill placement.

Below are two photographs of typical materials used during construction.

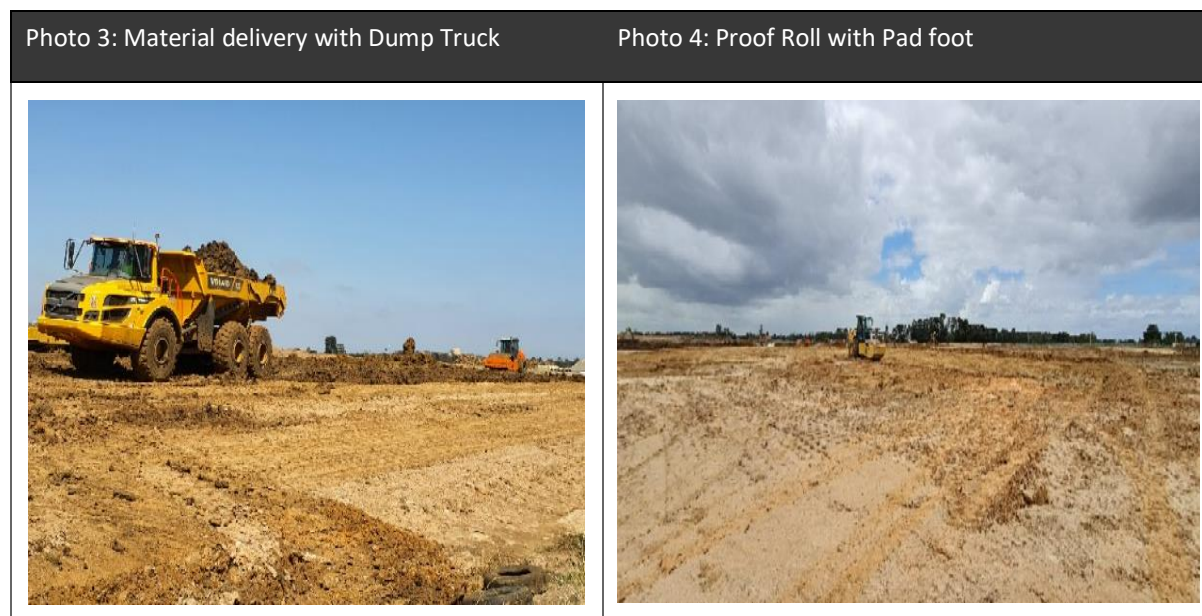
*Figure 3.2: Subgrade assessment photographs*

The subgrade inspections were performed in accordance with the Level 1 guidelines presented in AS 3798–2007 Section 5.5. No soft spots or deflections were encountered during the inspections and the area was found to be firm and free of vegetation and other deleterious material.

Below are two photographs of the subgrade assessment and material delivery at the project.

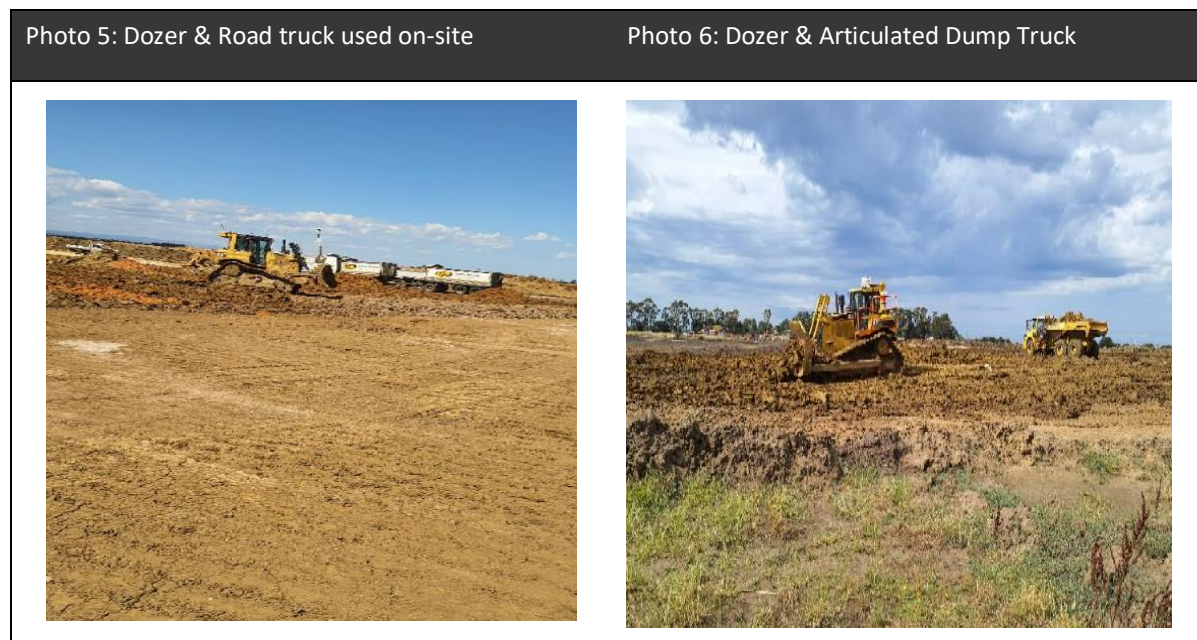
*Figure 3.3: General Earthwork machinery and fill construction photographs*

All fill material was brought by dump trucks from the local stockpiles, spread with a bulldozer and compacted with a pad foot roller. A water cart was present onsite during the works for moisture conditioning of the materials.

Below are two photographs of typical machinery on site and materials used during construction.

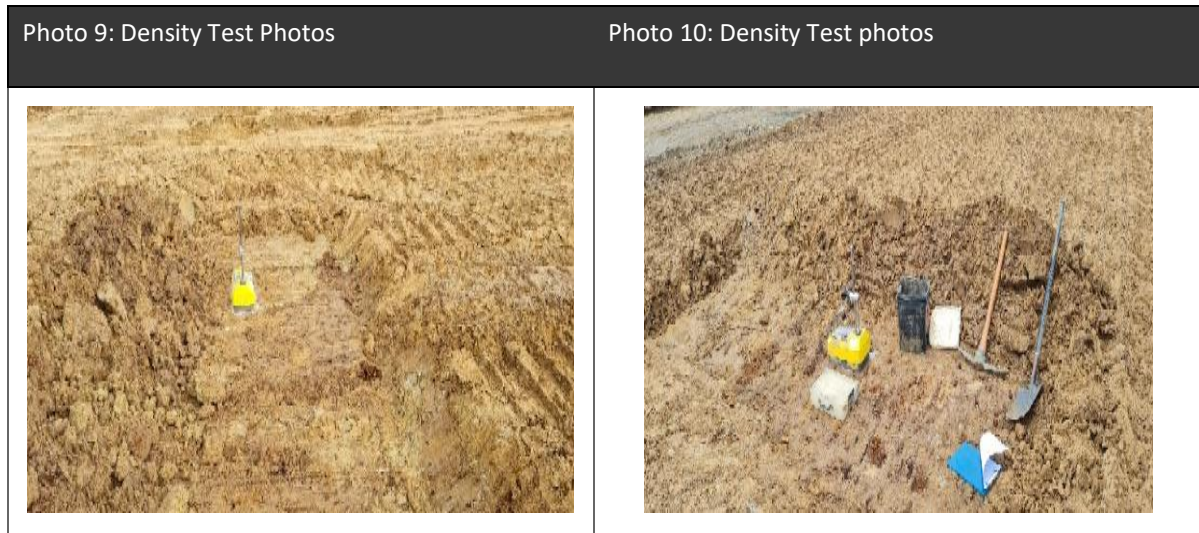
*Figure 3.4: Density Testing photographs*

Fifty-One (51) tests were performed during the filling process. Two (2) of the tests did not achieve the required density and or moisture ratio initially. The failed areas were reworked and retested accordingly. The retests returned passing density and moisture test results.

Below, two photographs of field density testing conducted on site.
