Level 1 Geotechnical Testing and Inspection Authority Services

**Riverfield Estate Stage 11
Lots 1101 to 1150**

Our Ref: 1016363.011.v1

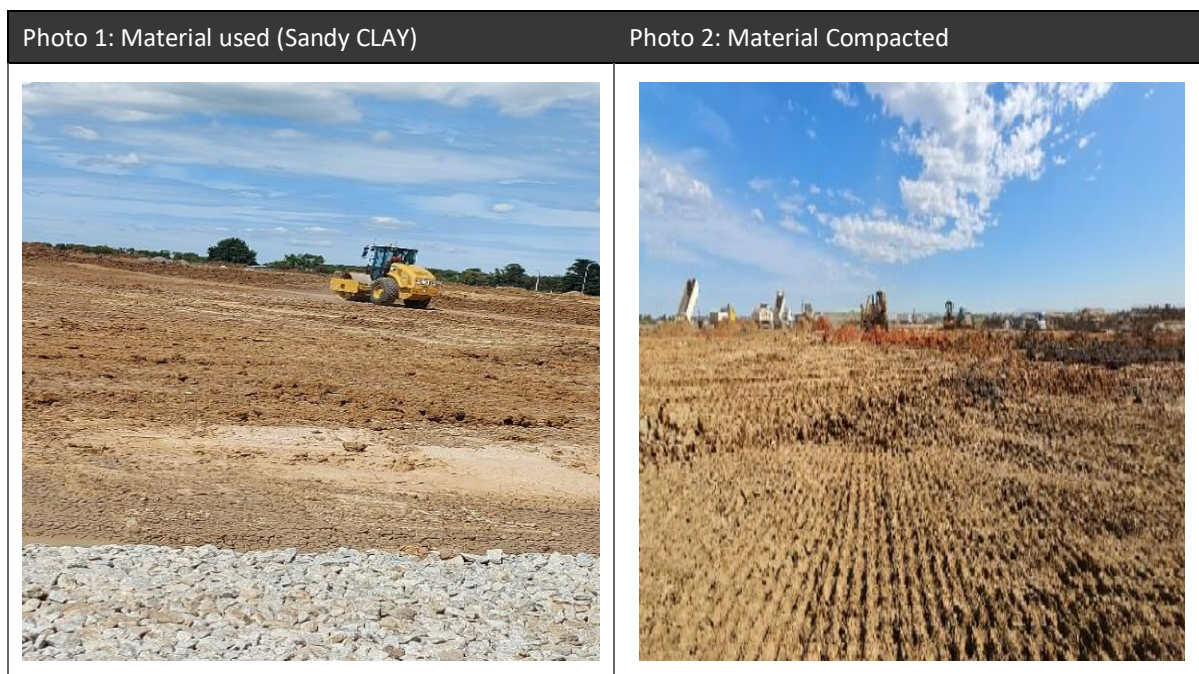
Figure 3.1: Photographs of the material used on site

Material used for the construction of the fill comprised of local gravelly and silty clays won from the road boxing and trench excavations on this and surrounding site materials.

The laboratory test results indicated material is clay of medium to high plasticity and satisfied the requirements of the Specification.

The material was deemed as being derived from natural soils. The soil is considered as 'Suitable Material' in accordance with Section 4.4 of the AS3798-2007.

Any observed organic or deleterious matter including any oversize cobbles or boulders were removed from the tested areas during the fill placement.

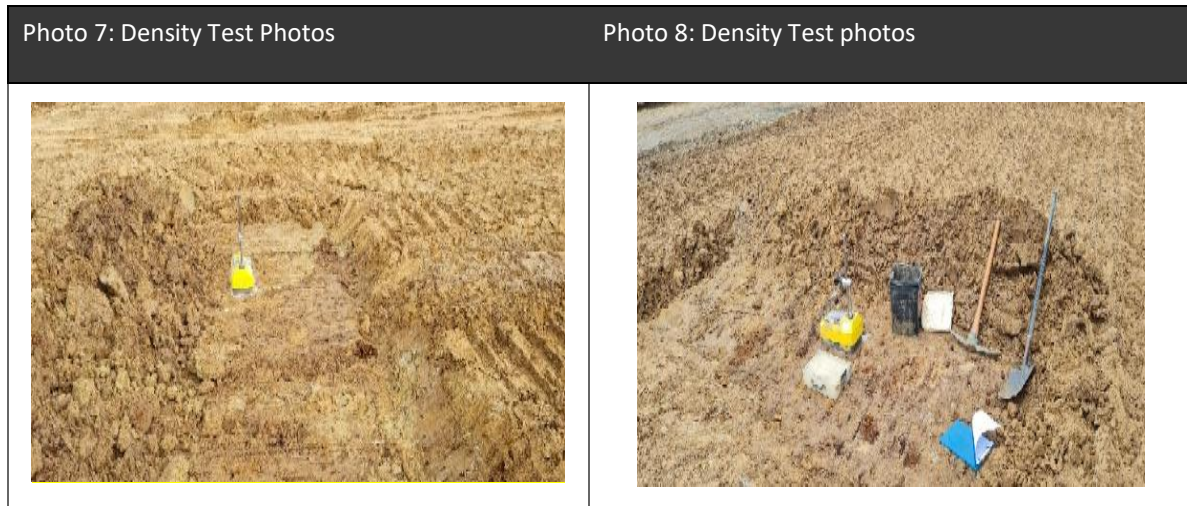
Figure 3.4: Density Testing photographs

Seventy-Six (76) tests were performed during the filling process across the site. Eight (8) of the tests did not achieve the required density and or moisture ratio initially. The failed areas were reworked and retested and the retests returned passing density and moisture test results.

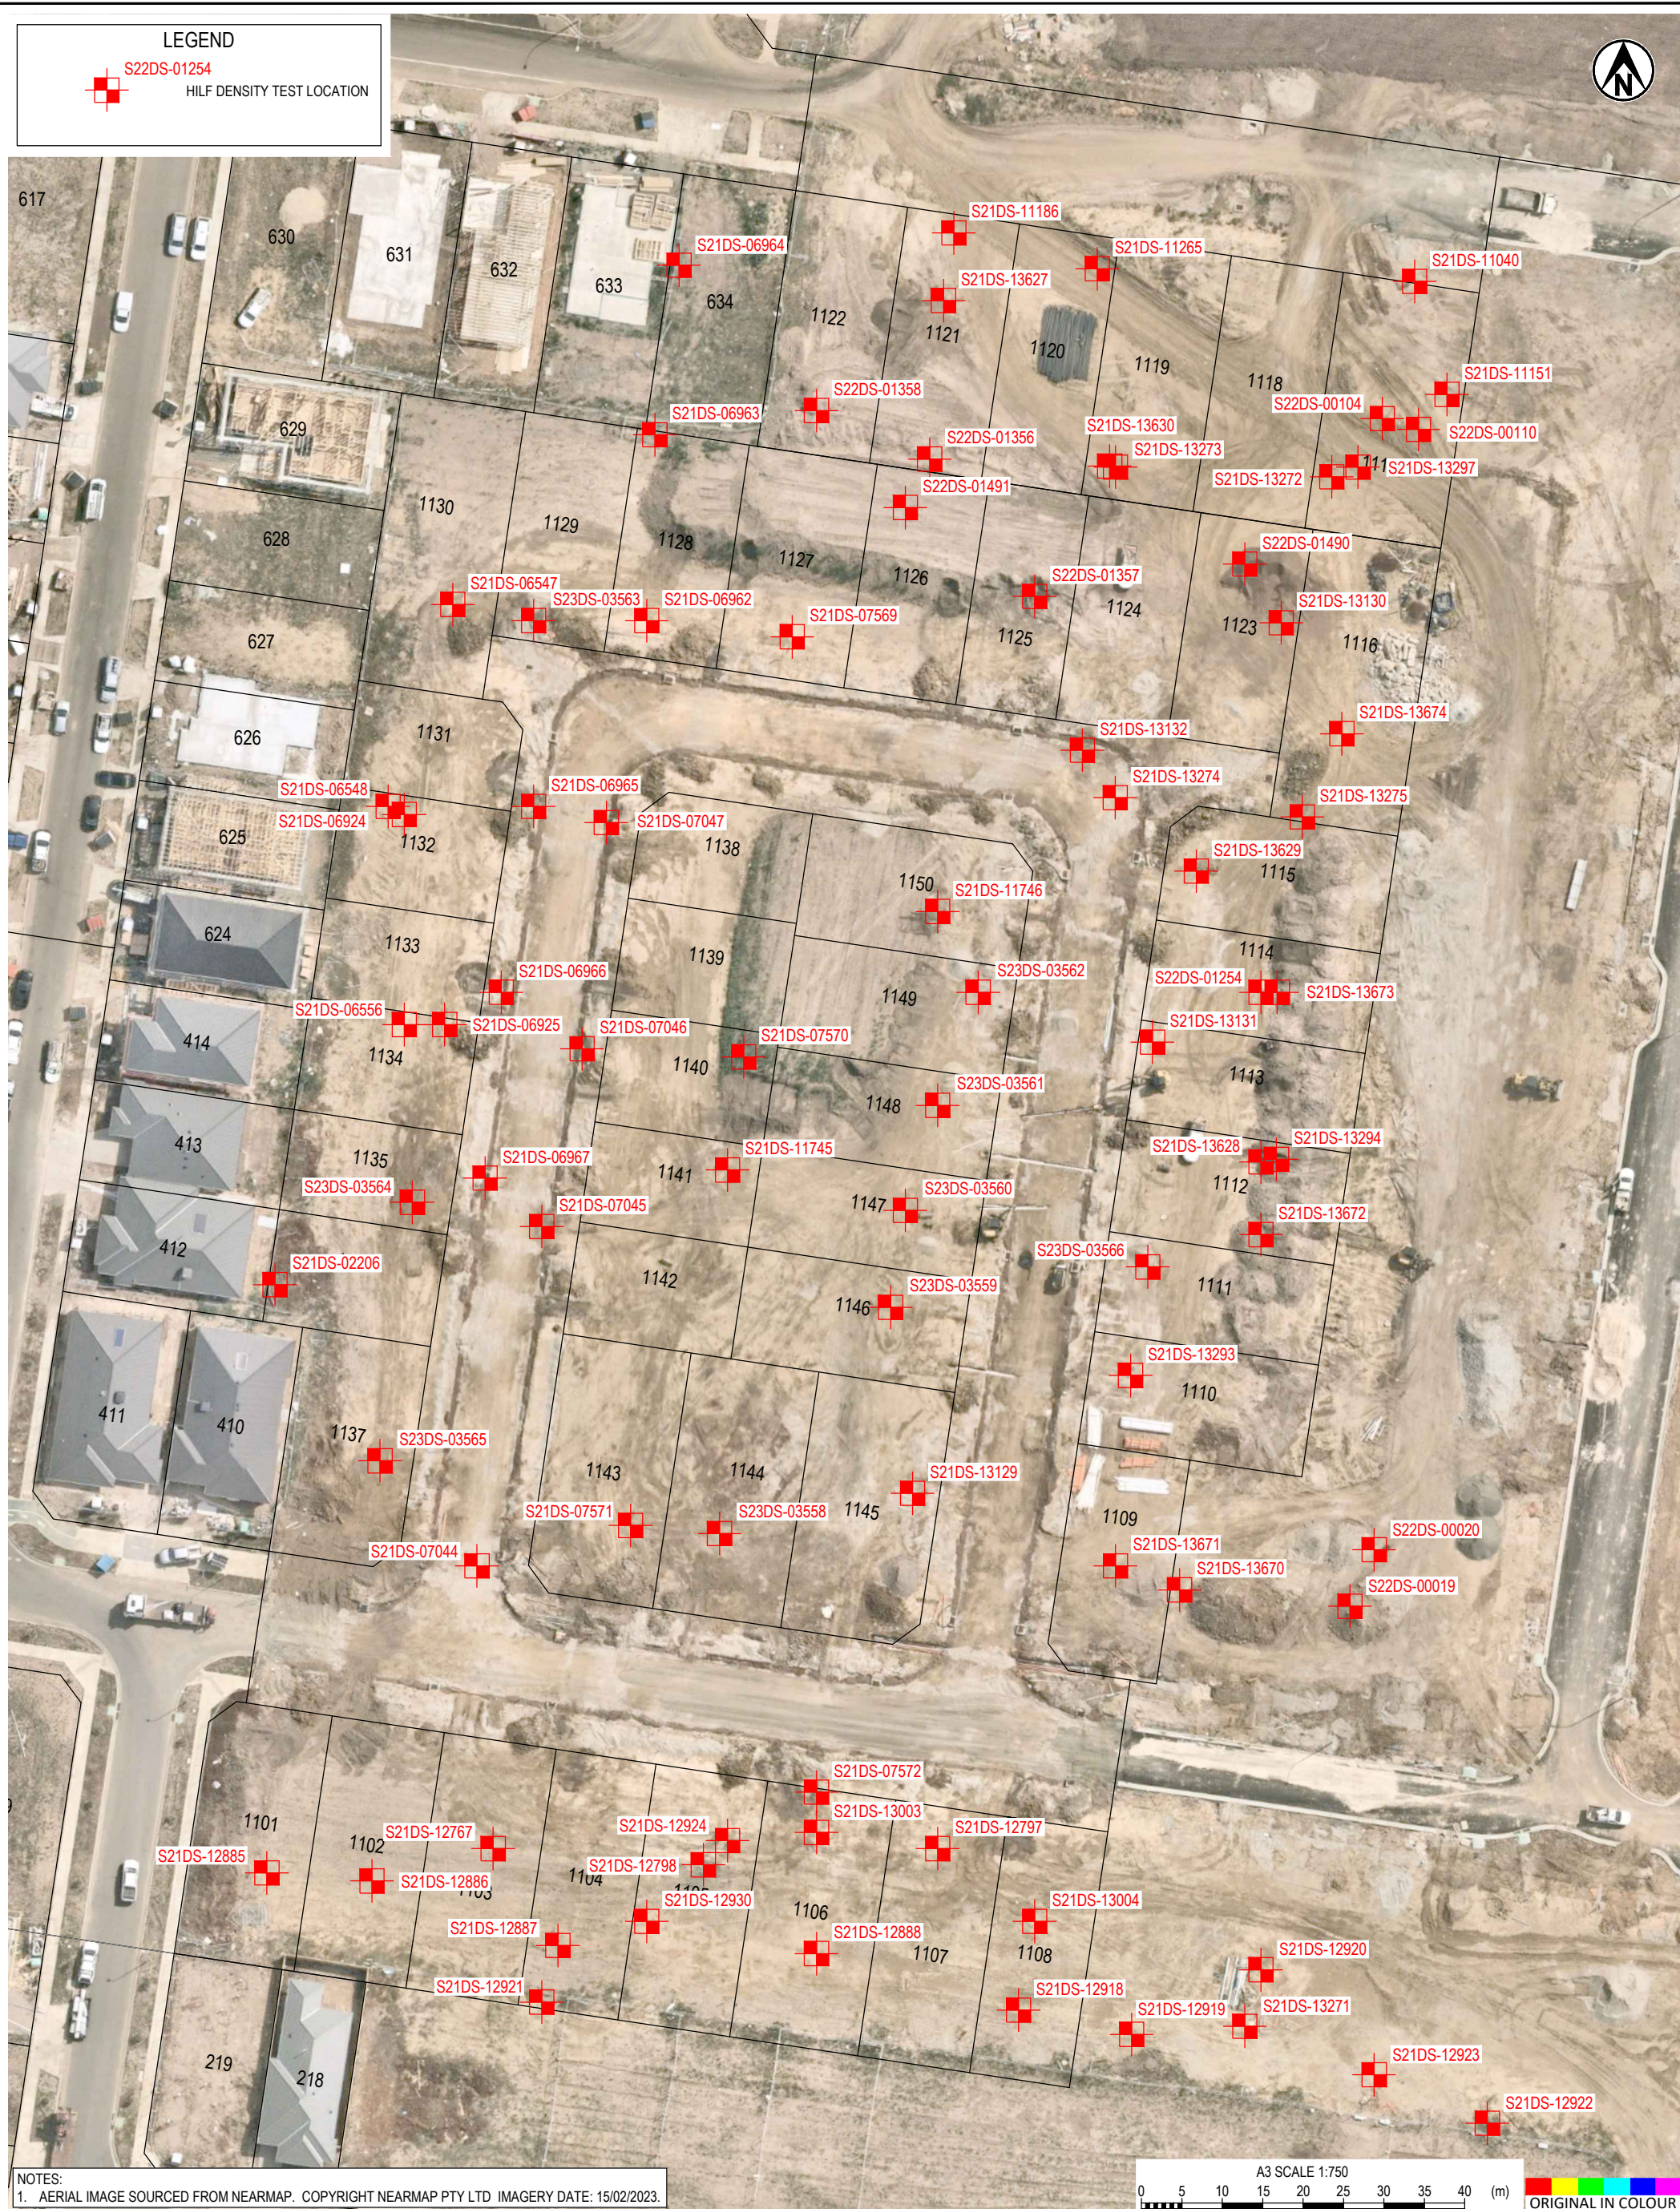
S22DS-01254
HILF DENSITY TEST LOCATION
