Level 1 Geotechnical Testing and Inspection Authority Services

**Riverfield Estate Stage 12
Lots 1201 to 1245**

Our Ref: 1016363.012.v1

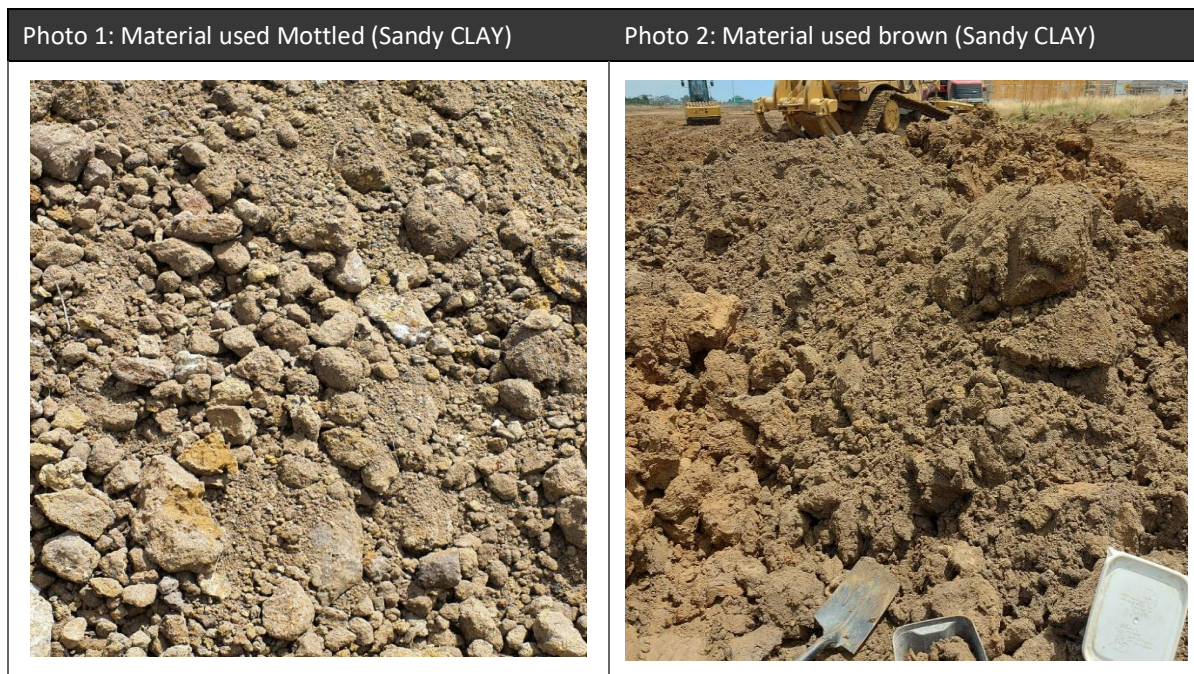
Photograph 4.1: Photographs of the material used on site

Any observed organic or deleterious matter including any oversize cobbles or boulders were removed from the tested areas during the fill placement.

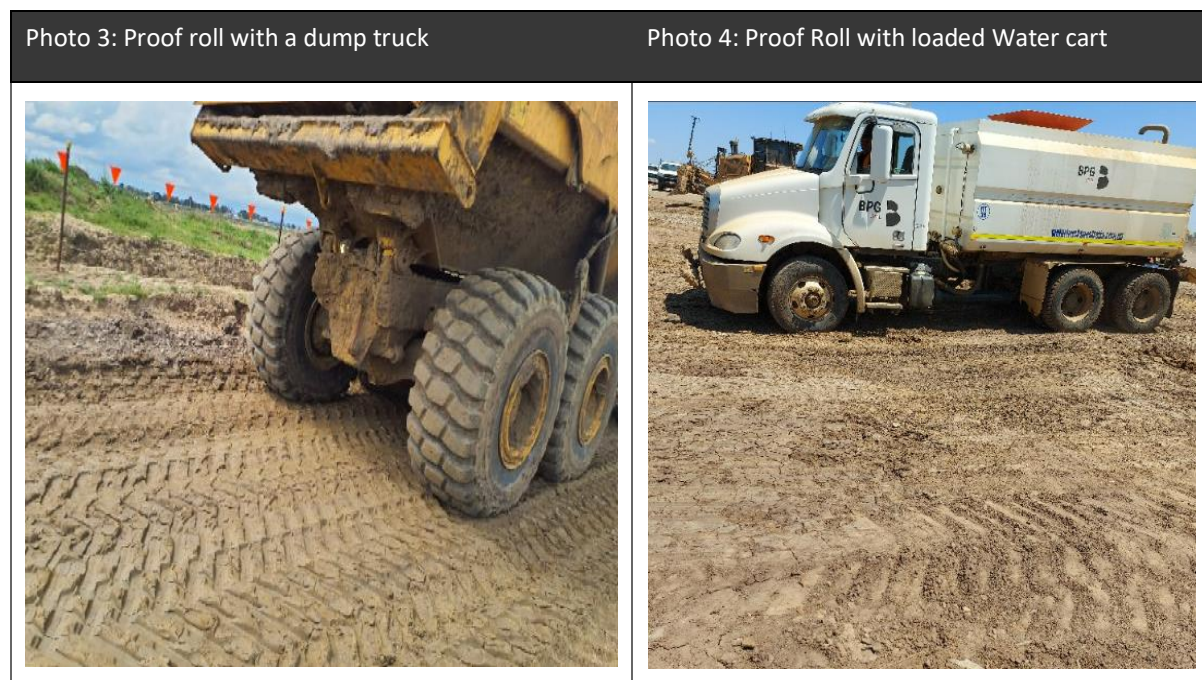
Photograph 4.2: Subgrade assessment photographs

The subgrade inspections were performed in accordance with the Level 1 guidelines presented in AS 3798–2007 Section 5.5. No soft spots or deflections were encountered during the inspections and the area was found to be firm and free of vegetation and other deleterious material.

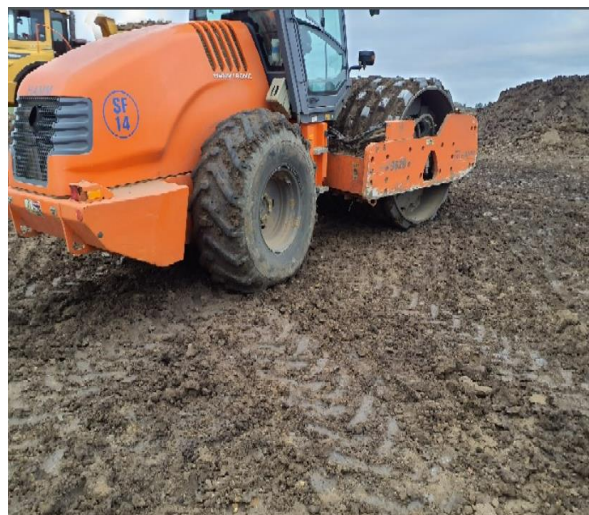
Photo 5: Pad Foot Roller used on site

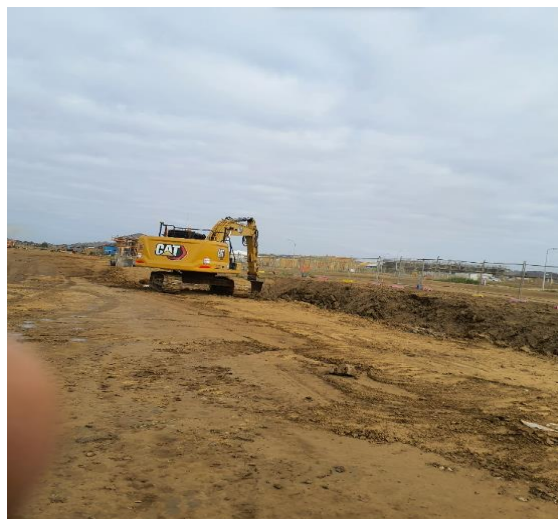
Photo 6: Excavator stripping to subgrade

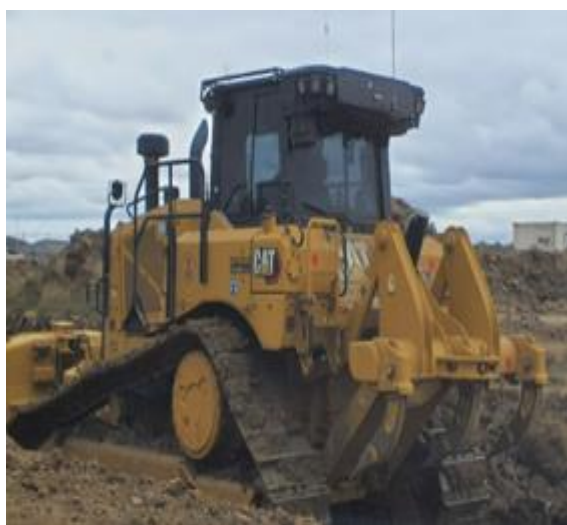
Photo 7: Dozer spreading clay

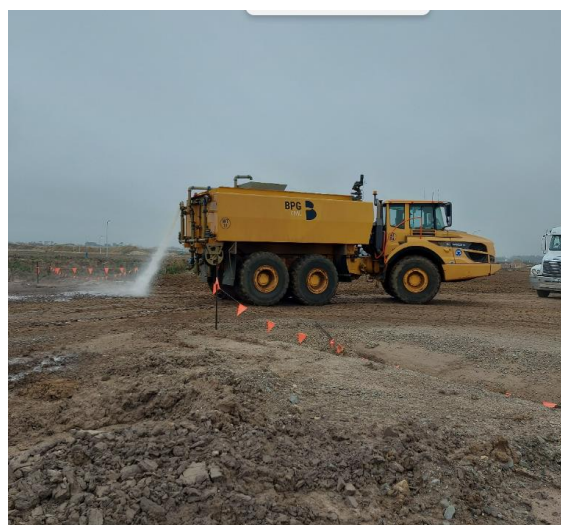
Photo 8: Water cart moisture conditioning

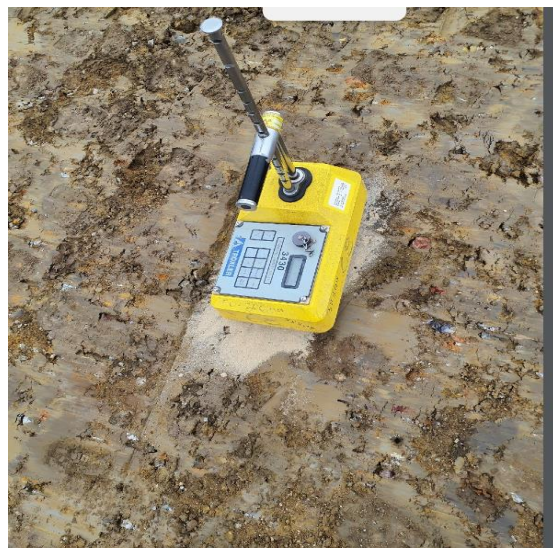
One hundred and forty-six (146) tests were performed during the filling process across the site. Four (04) of the tests did not achieve the required density and or moisture ratio initially. The failed areas were reworked and retested accordingly. The retests returned passing density and moisture test results.

Photo 9: Nuclear Density Test

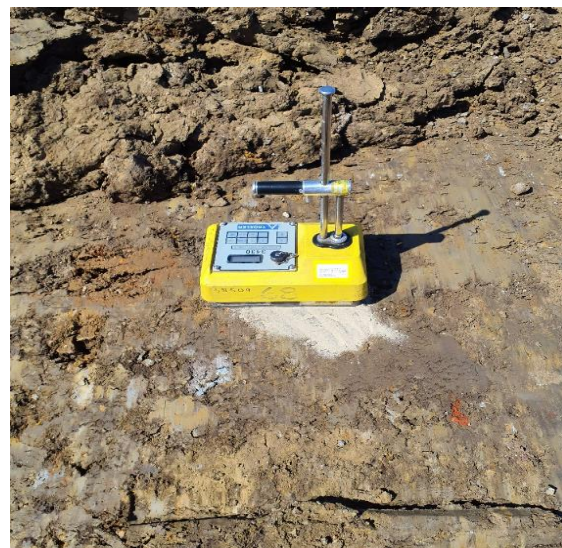
Photo 10: Pad Excavated for Nuclear Density Test
