Level 1 Geotechnical Inspection and Testing Authority Services

**Riverfield Square Estate Stage 23
Lots 2301 to 2330**

Our Ref: 1091938.023.v1

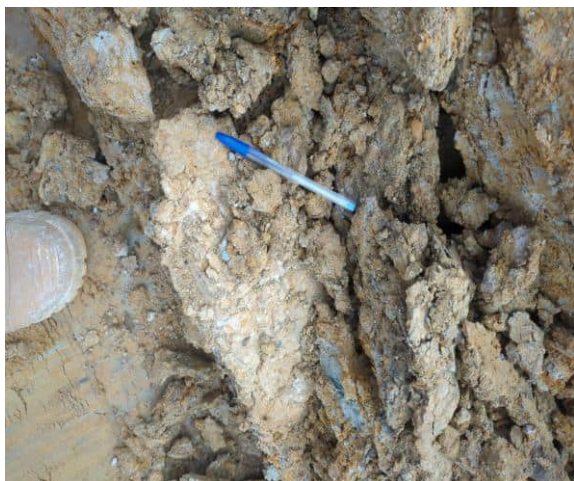
Photograph 1: Typical clay material used on site

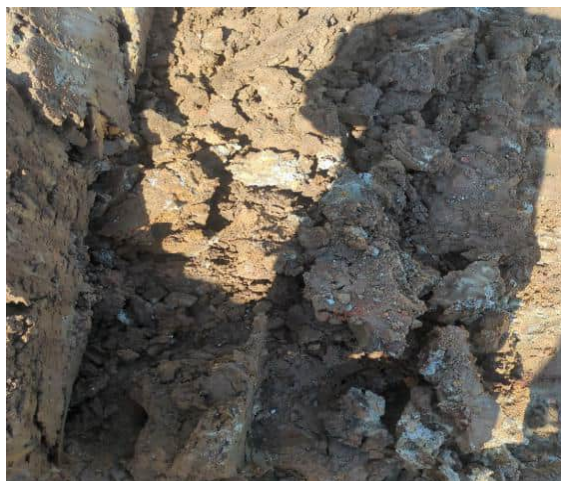
Photograph 2: Silty Sandy Clay used

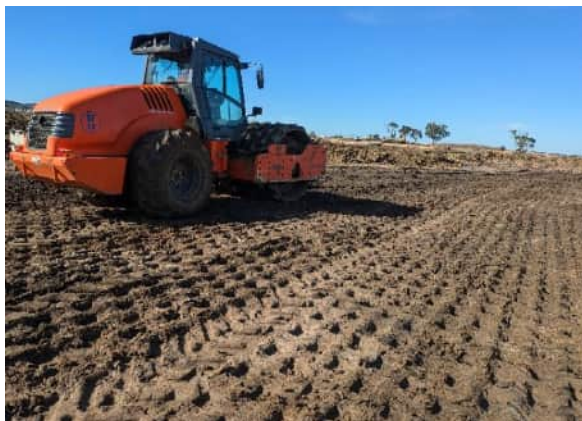
The subgrade inspections were performed in accordance with the Level 1 guidelines presented in AS 3798–2007 Section 5.5. No soft spots or deflections were encountered during the inspections and the area was found to be firm and free of vegetation and other deleterious material.

Photograph 3: Subgrade assessed with pad foot roller

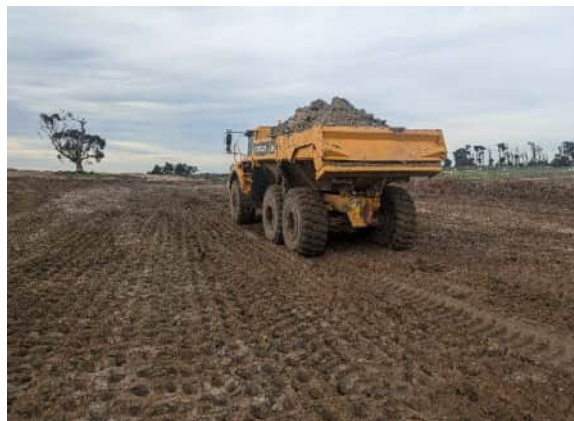
Photograph 4: Subgrade assessment using loaded dump truck

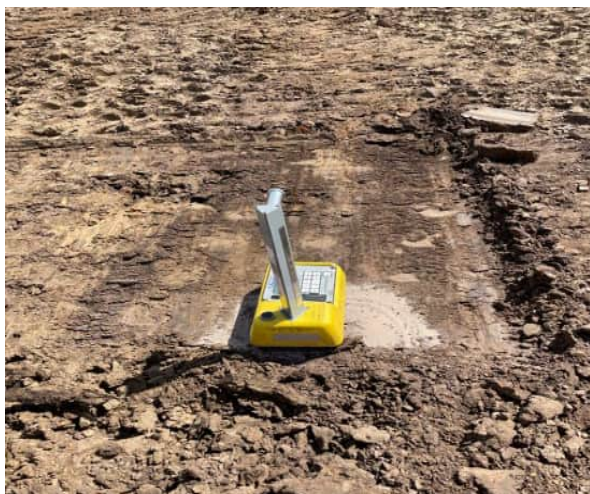
Fifty (50) tests were performed during the subgrade assessment and the filling process. Two (2) of the tests did not achieve the required density and or moisture ratio initially. The failed areas were reworked and retested accordingly. The retests returned passing density and moisture test results.

Photo 9: Field density/moisture test

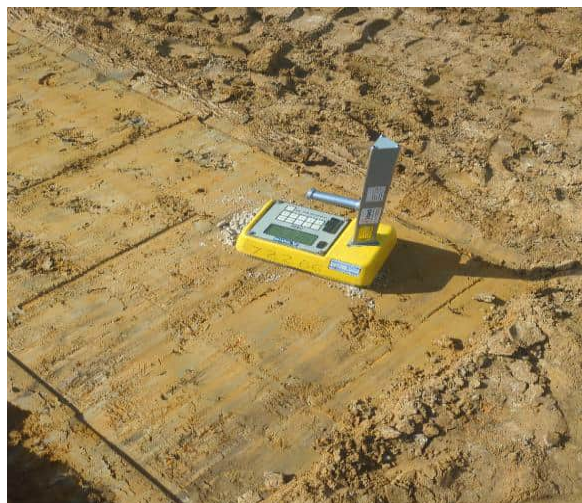
Photo 10: Field density/moisture test
