Level 1 Geotechnical Inspection and Testing Authority Services

**Riverfield Square Estate Stage 35
Lots 3501 to 3528**

Greenridge Properties Pty Ltd

Our Ref: 1091938.035.v1

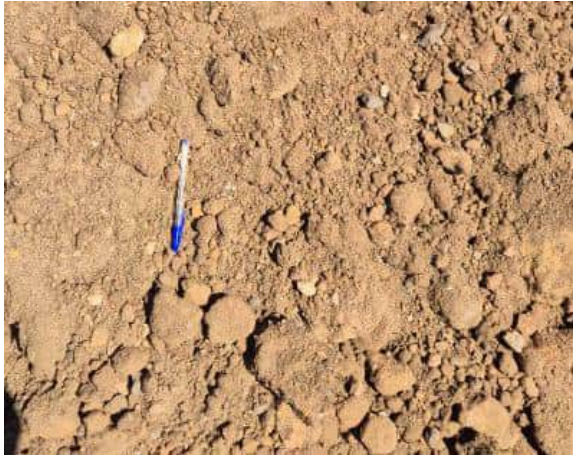
Photograph 1: Typical clay material used on site

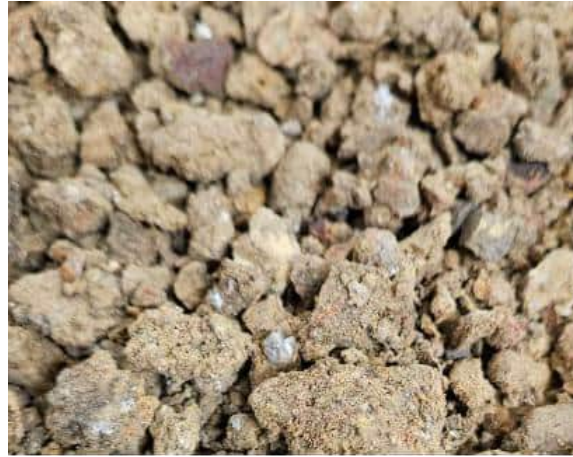
Photograph 2: Sandy Clay used

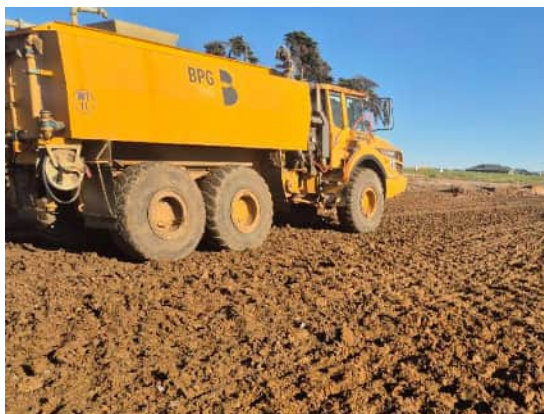
The subgrade inspection was performed in accordance with the Level 1 guidelines presented in AS3798–2007 Section 5.5. No soft spots or deflections were encountered during the inspections, and the area was found to be firm and free of vegetation and other deleterious material.

Photograph 3: Subgrade assessed with water truck

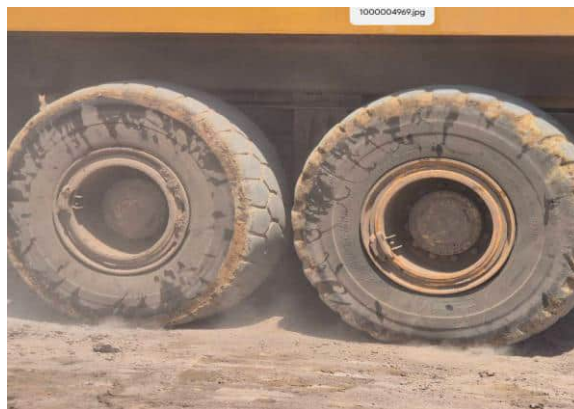
Photograph 4: Subgrade assessment

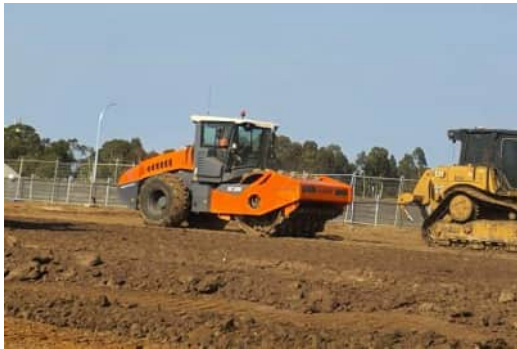
Photograph 5: Pad foot used during fill construction

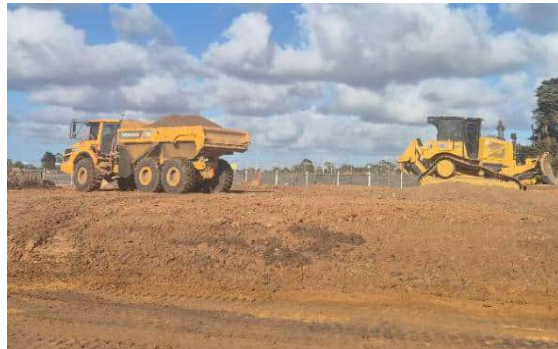
Photograph 6: Import of materials used during fill construction

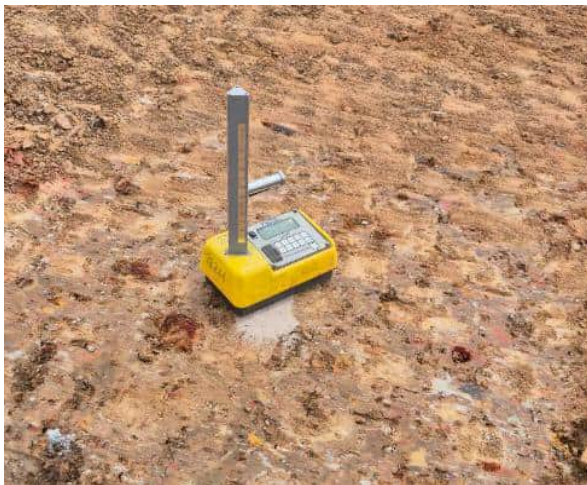
Forty-two (42) tests were performed during the filling process. Six (6) of the tests did not achieve the recommended density or moisture ratio initially. These areas were reworked and retested accordingly. The retests returned passing density and moisture test results.

Photo 9: Field density/moisture test

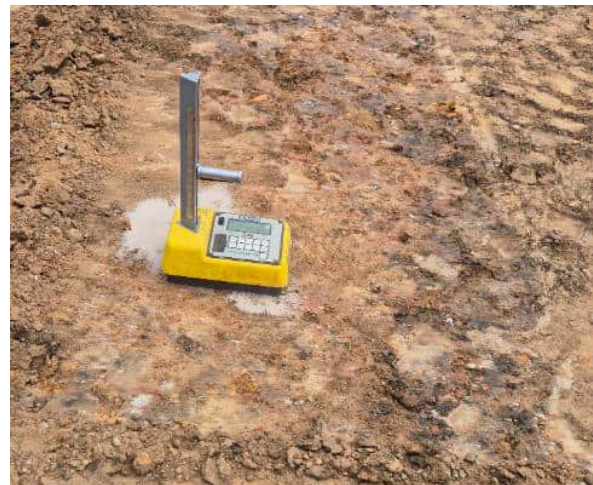
Photo 10: Field density/moisture test
