# **REPORT**

## **Level 1 Geotechnical Inspection and Testing Authority Services**

**Riverfield Square Estate Stage 28  
Lots 2801 to Lot 2829**

**Our Ref: 1091938.028.v1**

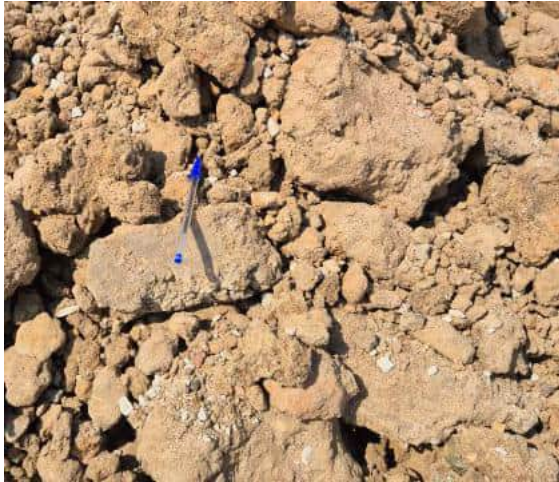
*Photograph 1: Typical clay material used on site*

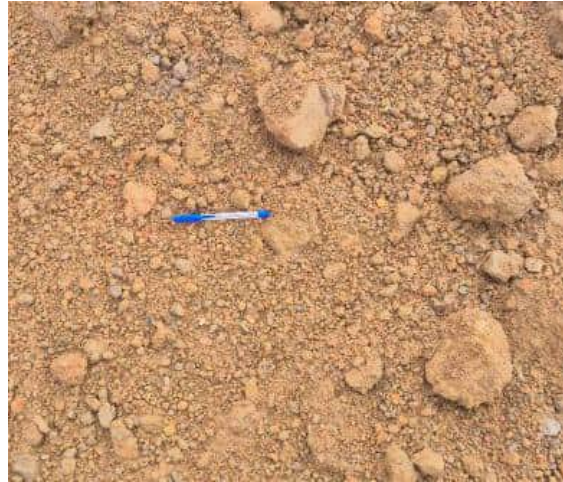
*Photograph 2: Sandy Clay used*

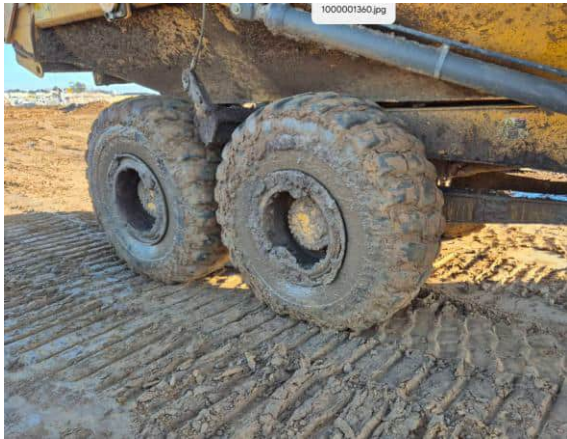
The subgrade inspection was performed in accordance with the Level 1 guidelines presented in AS3798–2007 Section 5.5. No soft spots or deflections were encountered during the inspections, and the area was found to be firm and free of vegetation and other deleterious material.

*Photograph 3: Subgrade assessed with dump truck.*

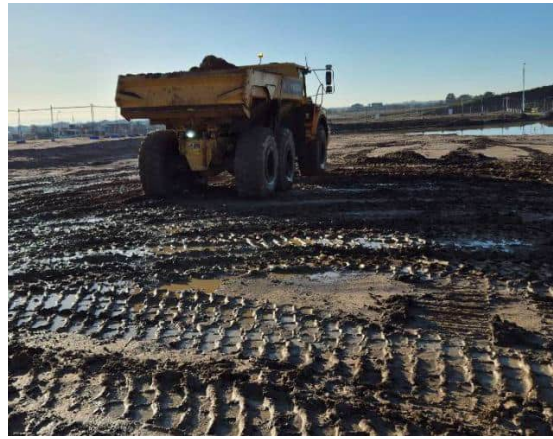
*Photograph 4: Subgrade assessment using loaded dump truck.*

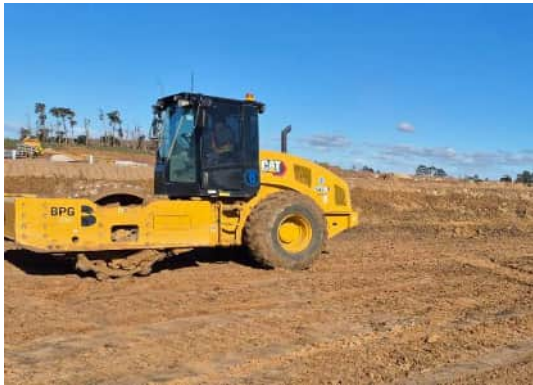
*Photograph 5: Vibrating pad foot roller used during fill construction.*

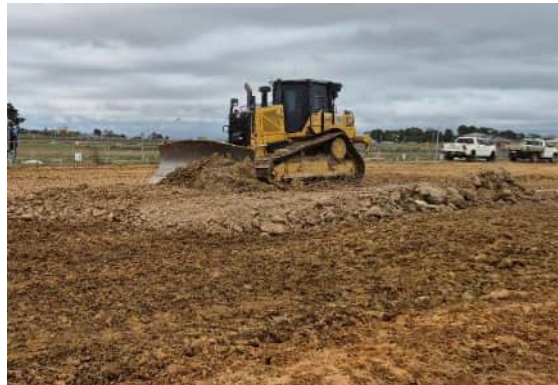
*Photograph 6: D6 Dozer spreading clay.*

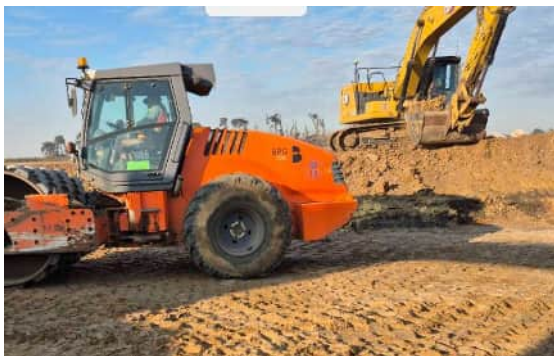
*Photograph 7: Excavator and vibrating pad foot roller used during construction.*

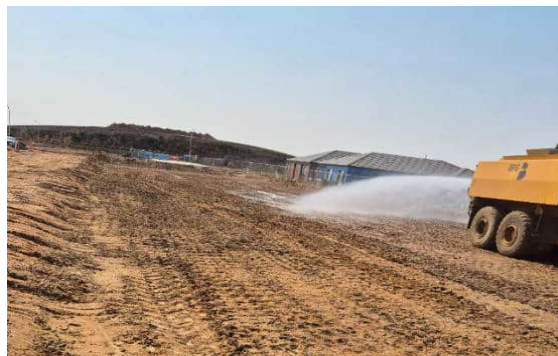
*Photograph 8: Water truck.*

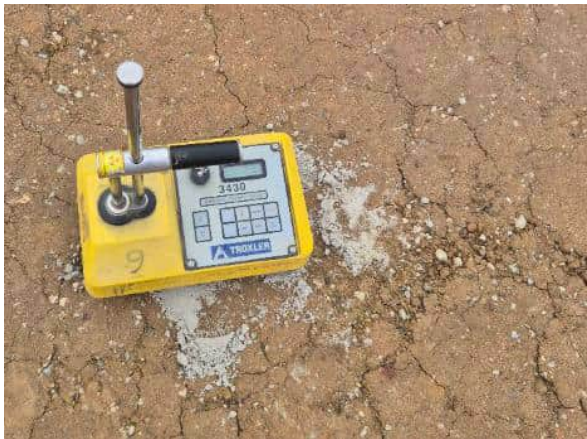
Forty-two (42) tests were performed during the filling process. Six (6) of the tests, did not achieve the required density and or moisture ratio. These areas were moisture conditioned and reworked and retested.

*Photo 9: Field density/moisture test*

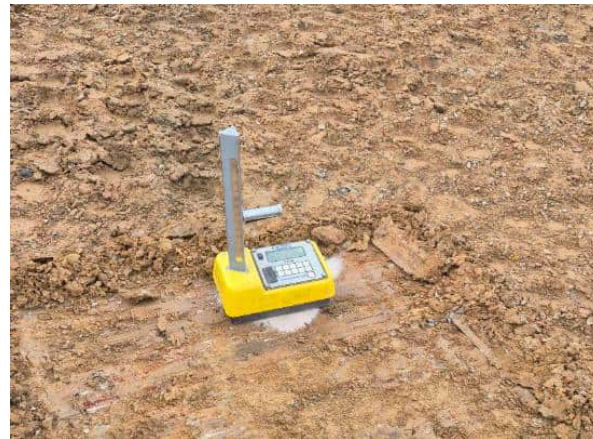
*Photo 10: Field density/moisture test*
