# REPORT

## Level One Inspection and Testing Services

Riverfield Estate Stage 1, Clyde  
Lot's 101 to Lot 141

Our Ref: 1016363.001.v1

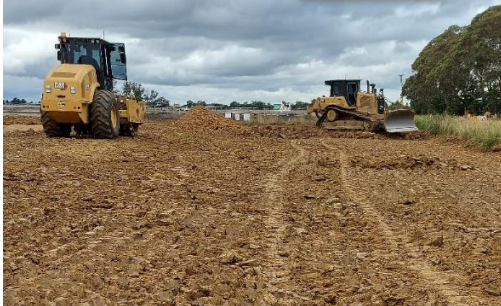
Photograph 2.7.1:  
Material Compaction

Below are two photographs of typical earthwork operations completed during earthworks, See Photographs 2.7.1 and 2.7.2 below.

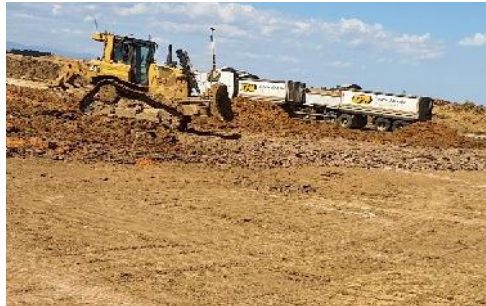
Photograph 2.7.2:  
Delivery and Conditioning

The fill was placed and compacted using vibrating Pad foot rollers. Water trucks with water cannons attached were used to moisture condition the soil materials. The layer thicknesses were controlled using earthwork machinery with built-in GPS systems.
