# REPORT

## Level One Inspection and Testing Services

Riverfield Estate Stage 2, Clyde  
Lot's 201 to Lot 242

11 April 2022  
Our Ref: 1016363.002.v1

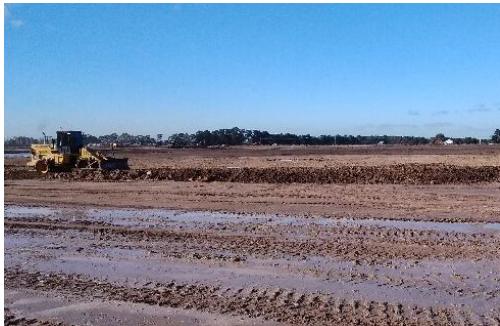
Below are two photographs of typical earthwork operations completed during earthworks, See Photographs 2.7.1 and 2.7.2 below.

Photograph 2.7.1:  
Material Compaction and Conditioning

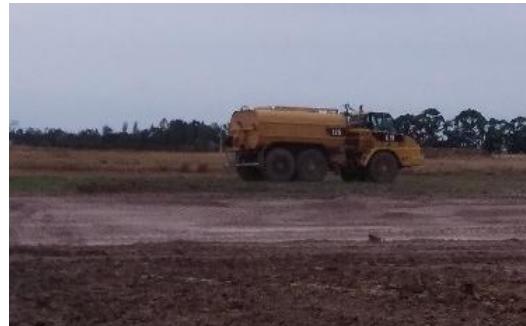
Photograph 2.7.2:  
Moisture Conditioning material
