# REPORT

## Level One Inspection and Testing Services

Riverfield Estate Stage 5, Clyde  
Lot's 501 to Lot 549

16 May 2022  
Our Ref: 1016363.005.v2

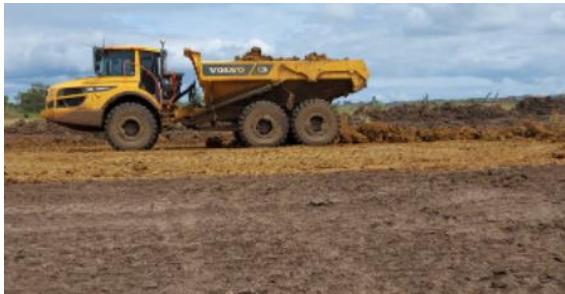
Photograph 2.7.1:

Material Placement

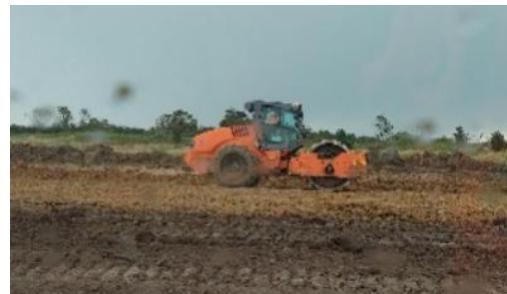
Photograph 2.7.2:

Material Compaction

The fill was placed and compacted using vibrating Pad foot rollers. Water trucks with water cannons attached were used to moisture condition the soil materials. The layer thicknesses were controlled using earthwork machinery with built-in GPS systems.
