# **REPORT**

## **Level 1 Inspection and Testing Services**

**Riverfield Estate Stage 3, Clyde  
Lots 301 to 341**

**Our Ref: 1016363.003.v1**

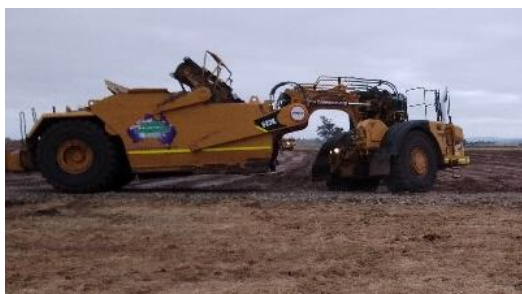
Photograph 2.7.1:  
Material Placement

Below are two photographs of typical earthwork operations completed during earthworks, See Photographs 2.7.1 and 2.7.2 below.

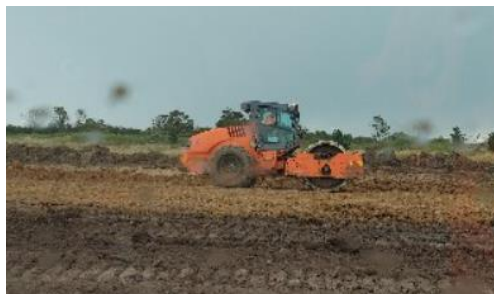
Photograph 2.7.2:  
Material Compaction

The fill was placed and compacted using vibrating Pad foot rollers. Water trucks with water cannons attached were used to moisture condition the soil materials. The layer thicknesses were controlled using earthwork machinery with built-in GPS systems.

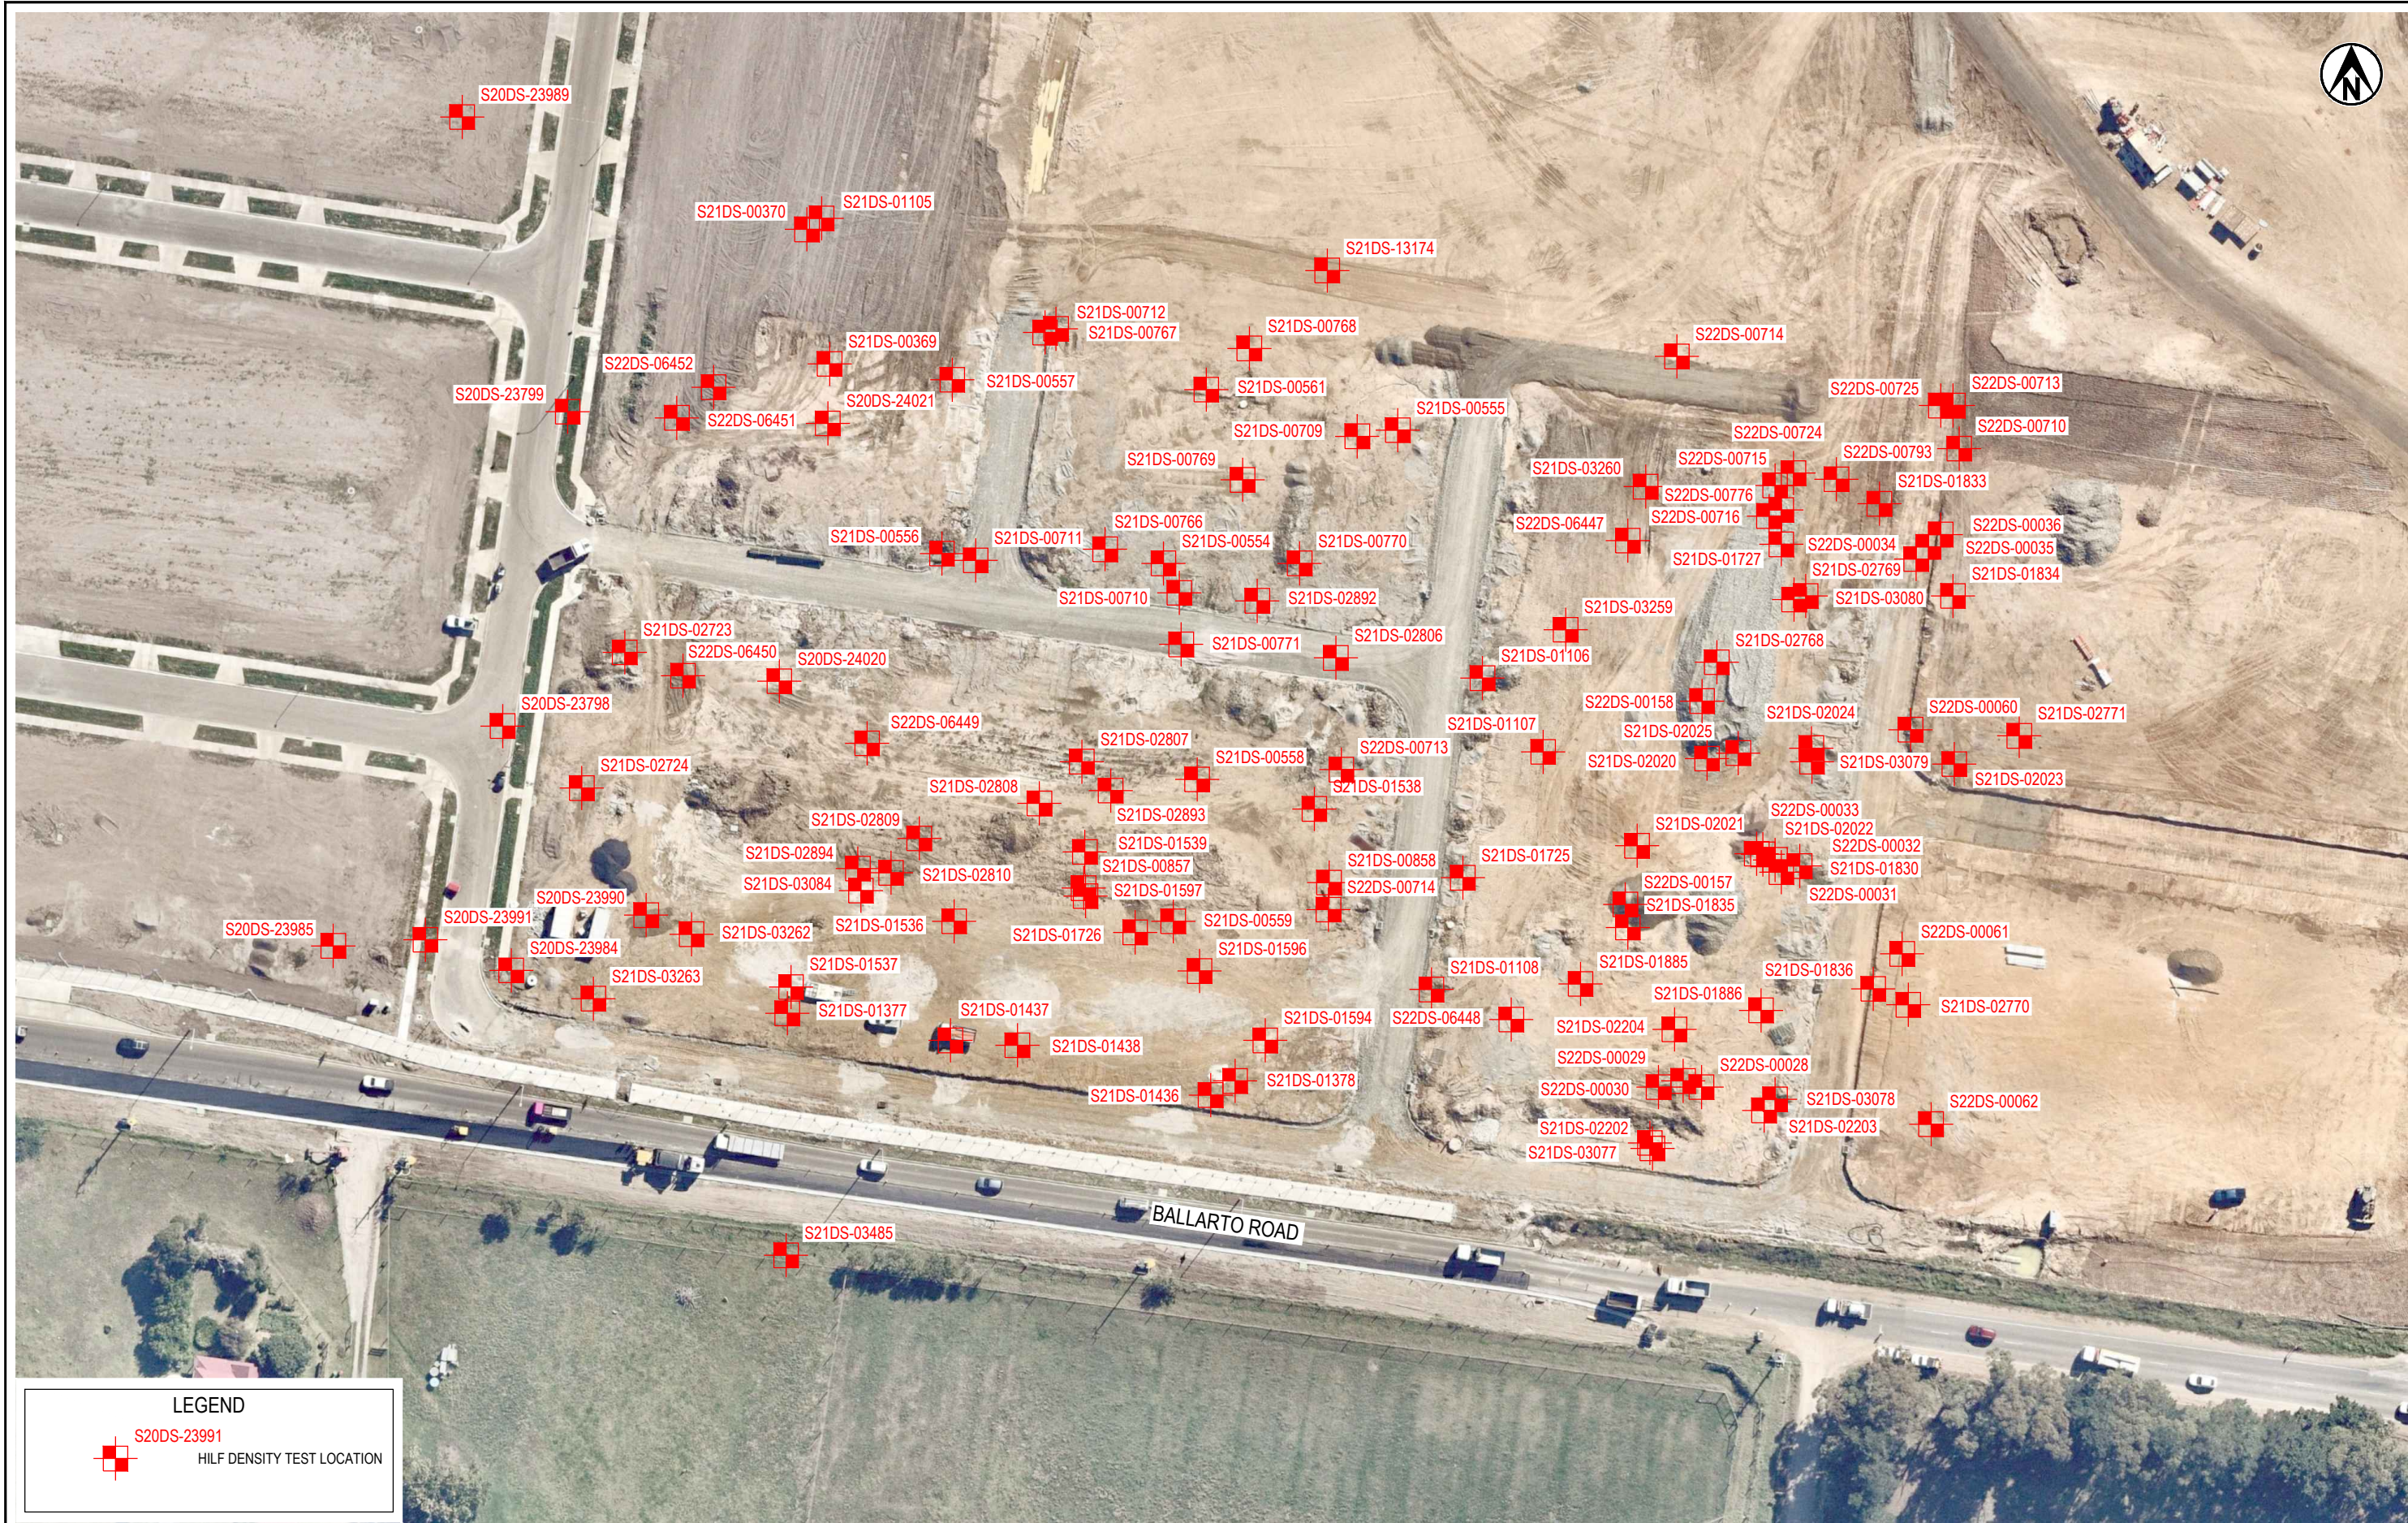
A site plan of the site is included in Appendix A.
