# REPORT

## Level One Inspection and Testing Services

Riverfield Estate Stage 6, Clyde  
Lot's 601 to Lot 634

Our Ref: 1016363.006.v1

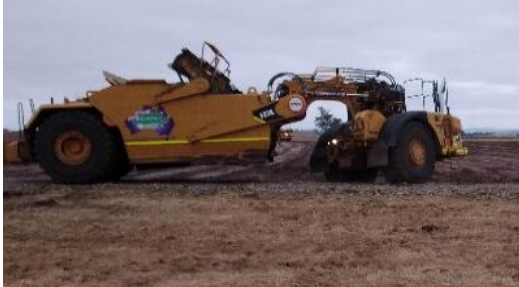
Photograph 2.7.1:  
Material Placement

The fill was placed and compacted using vibrating Pad foot rollers. Water trucks with water cannons attached were used to moisture condition the soil materials. The layer thicknesses were controlled using earthwork machinery with built-in GPS systems.
