# REPORT

## **Level 1 Geotechnical Testing Authority Inspection Services**

**Riverfield Estate Stage 9, Lots 901 to 948  
Clyde**

**10 October 2022**  
Our Ref: 1016363.009.v1

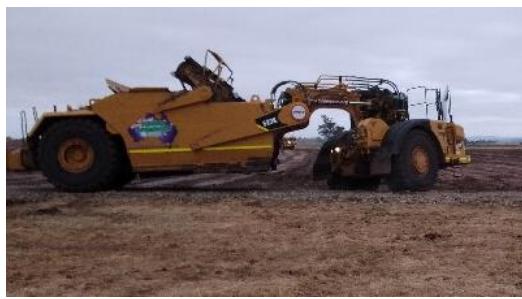
Photograph 2.7.1:

Below are two photographs of typical earthwork operations completed during earthworks, See Photographs 2.7.1 and 2.7.2 below.

Material Placement

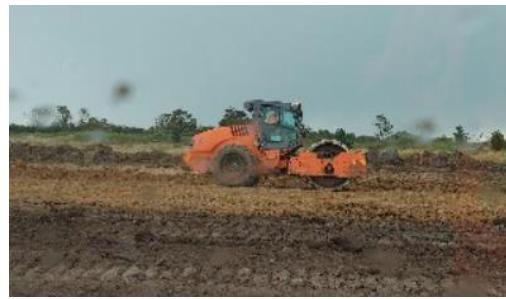
Photograph 2.7.2:

Material Compaction

The fill was placed and compacted using vibrating Pad Foot rollers. Water trucks with water cannons attached were used to moisture condition the soil materials. The layer thicknesses were controlled using earthwork machinery with built-in GPS systems.

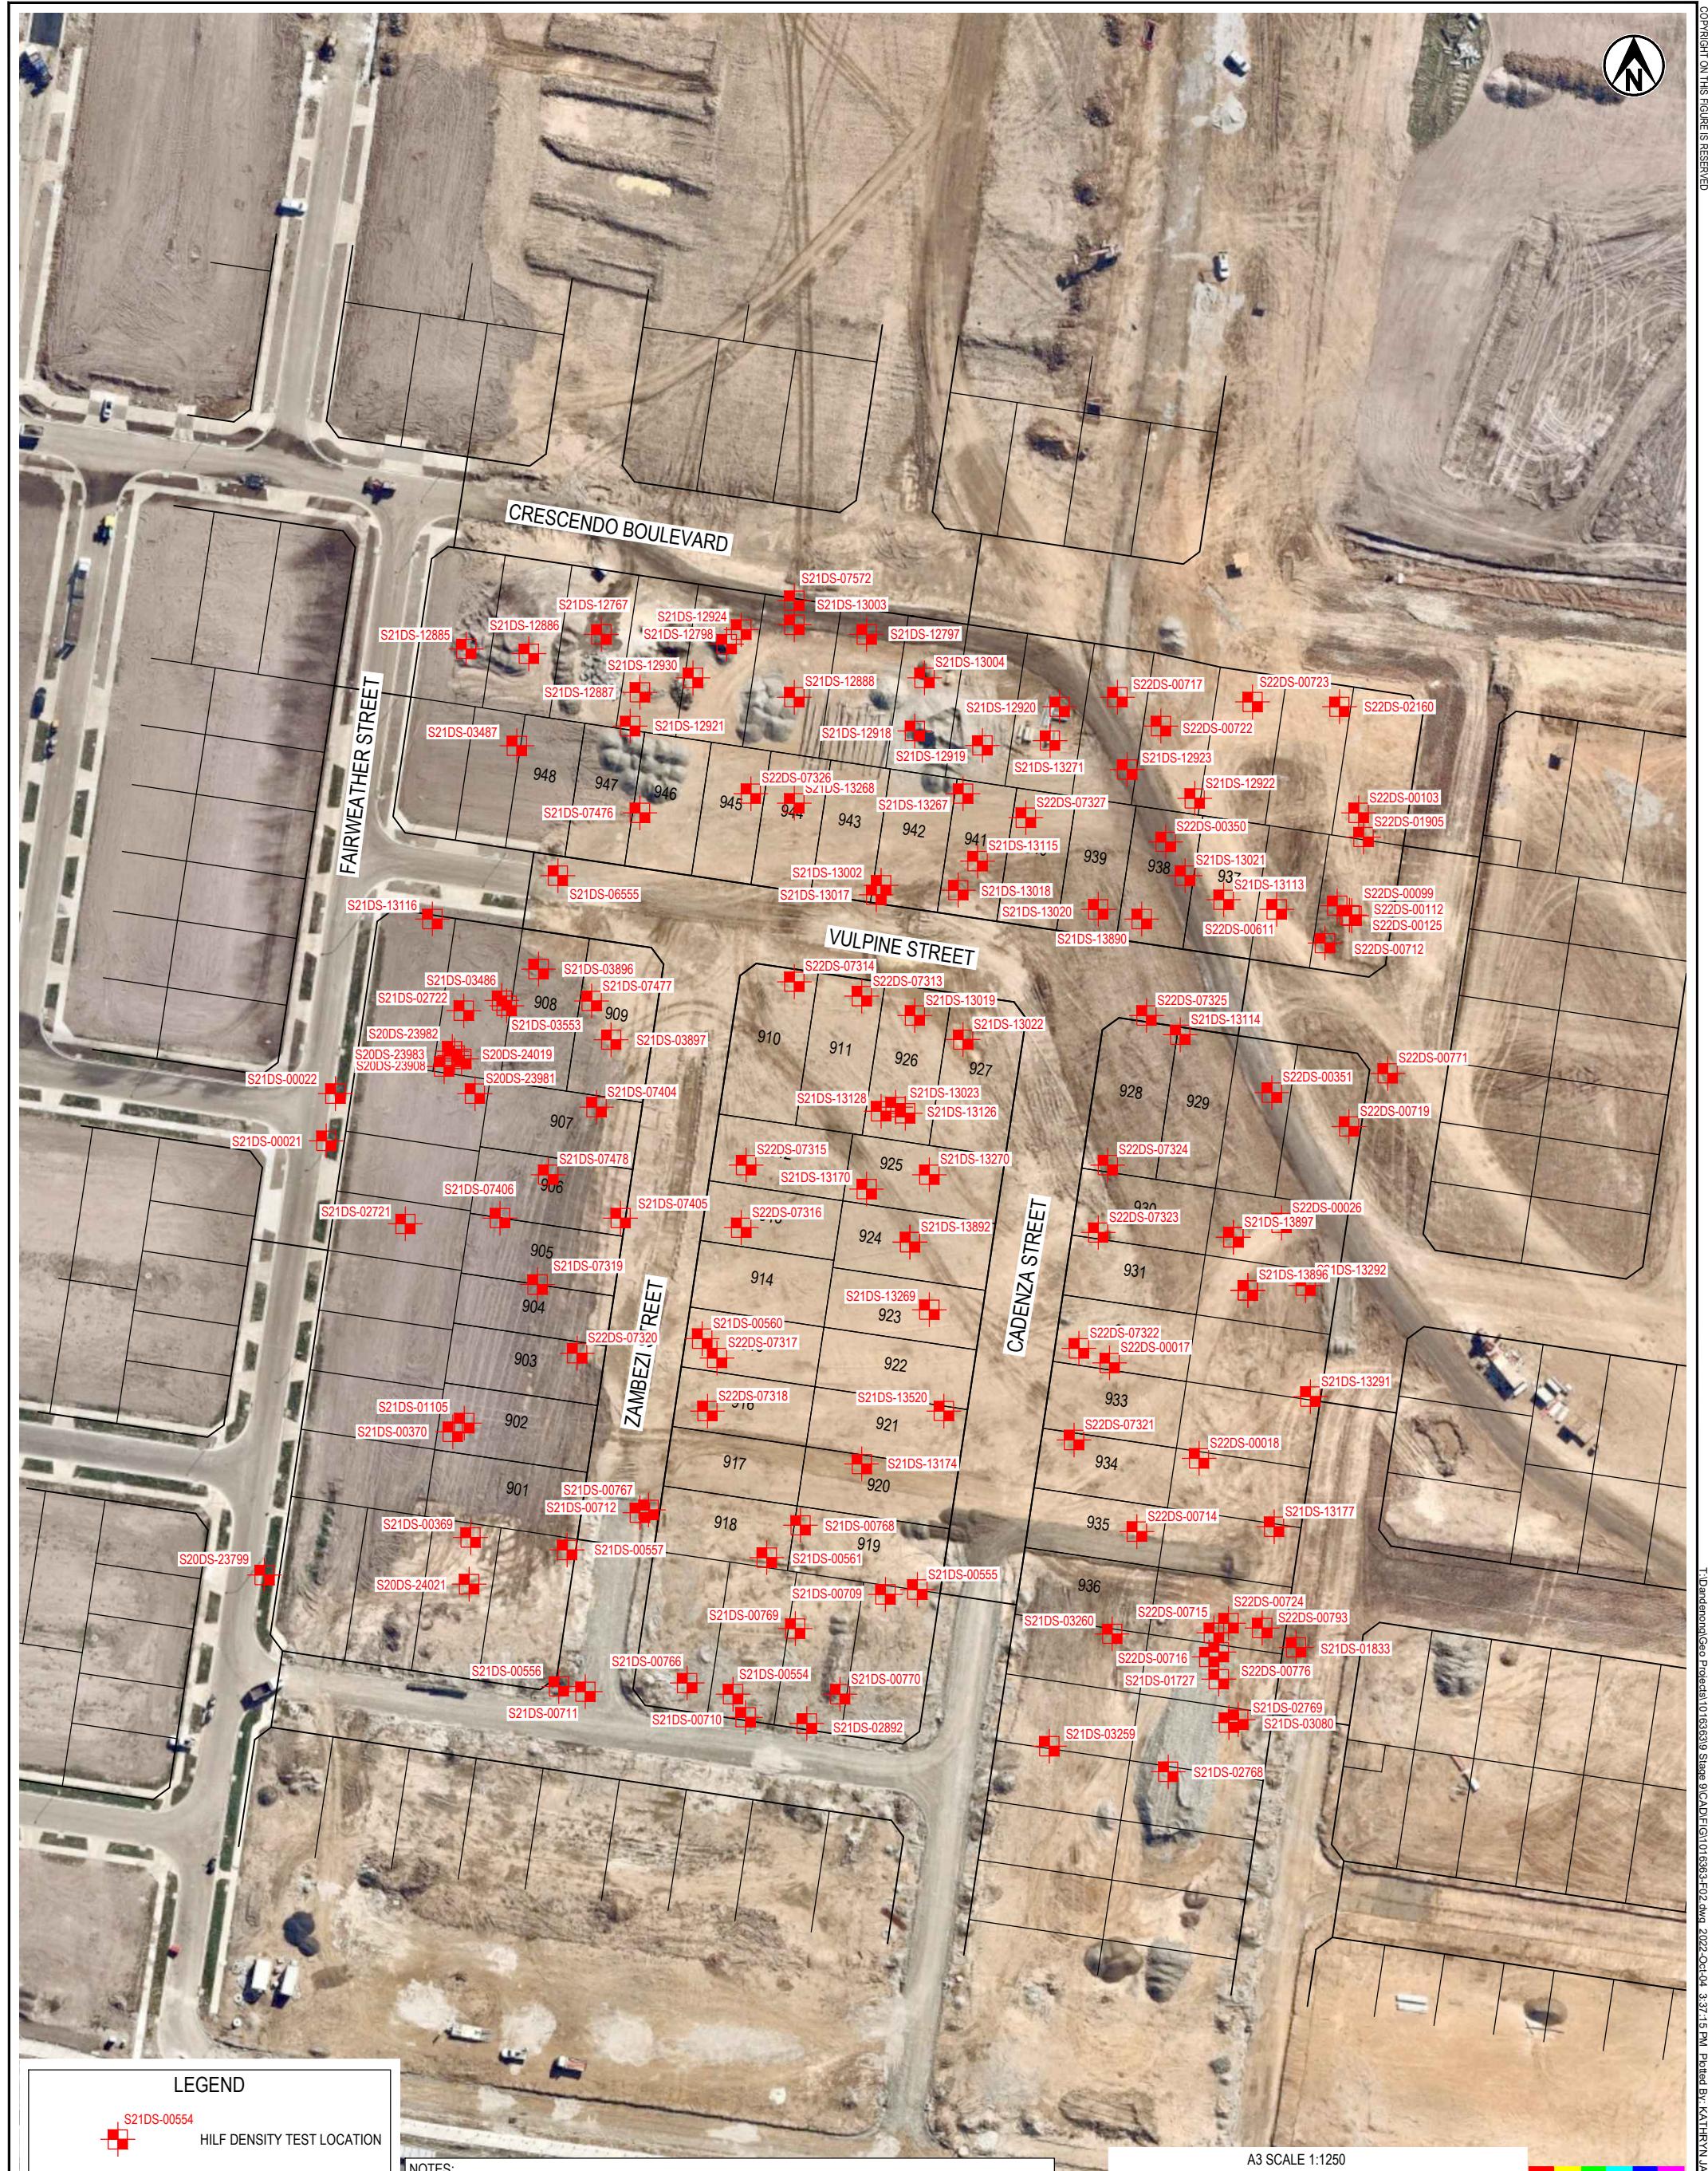
## **Appendix A : Location Plan**

A site plan of the working area is attached in Appendix A.
