REPORT

Level 1 Geotechnical Inspection and Testing Authority Services

**Riverfield Square Estate Stage 24
Lots 2401 to 2447**

Our Ref: 1091938.024.R1.v1

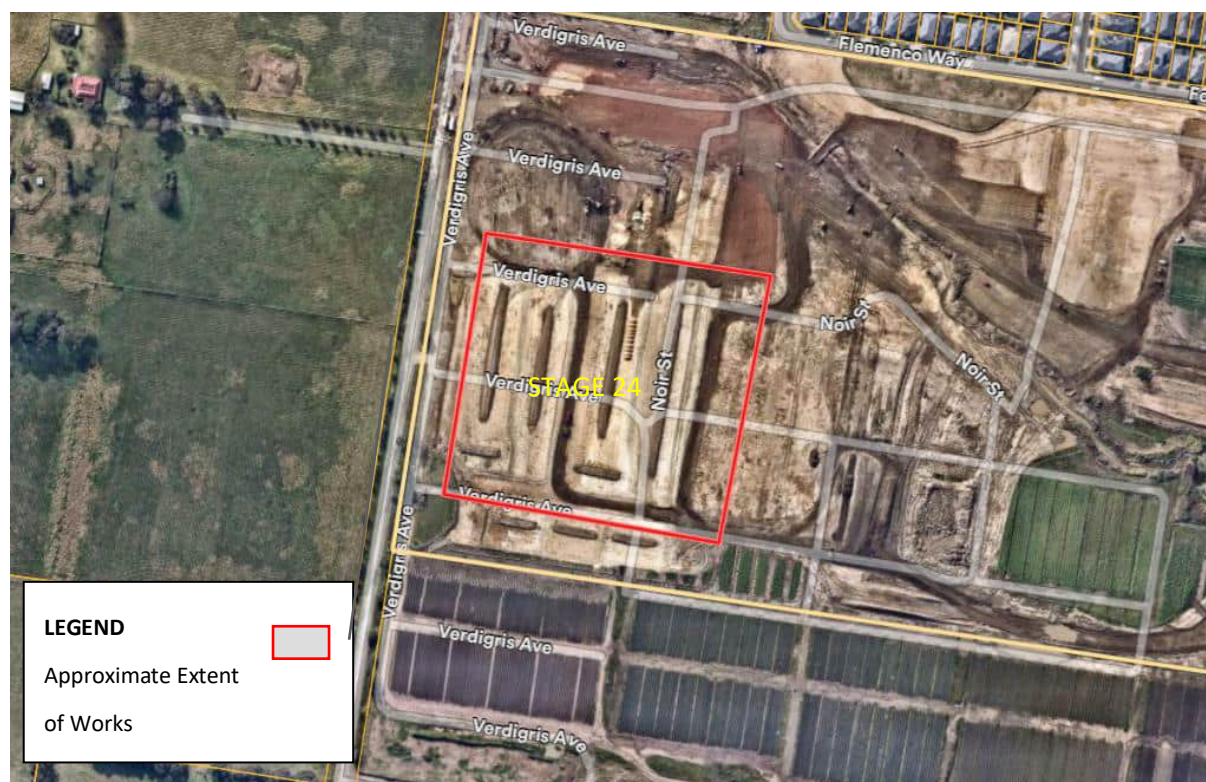
Figure 2.1: Extract from Nearmap

The included works are shown on the Site Plan in Appendix A and Figure 2.1 below is an extract from Nearmap.

This report is applicable to material placed by the contractor on the residential lots within Riverfield Square Estate Stage 24, as shown on **Figure 2.1** and on the Site Plan in **Appendix A**, and with reference to Section 2.5 (Excluded Areas) of this report.

This report does not include fill outside the general boundary of the filled areas as shown in **Figure 2.1**. No fill was placed on the lots not mentioned in Section 2.4 of this report.

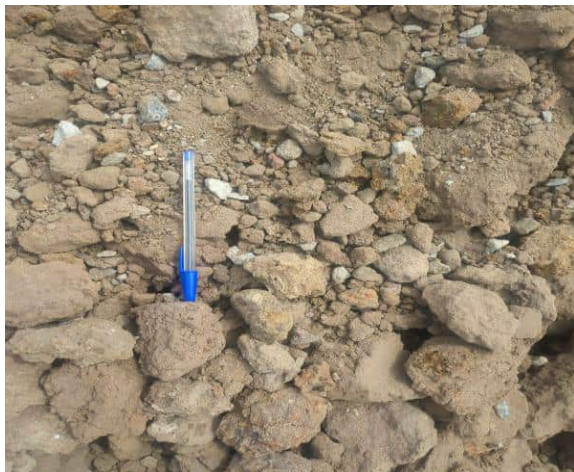
Material used for the construction of the fill comprised of local gravelly and silty clays won from the road boxing and trench excavations on this and the surrounding sites.

The laboratory test results indicated material is clay of medium to high plasticity and satisfied the requirements of the Specification.

Photograph 1: Typical clay material used on site

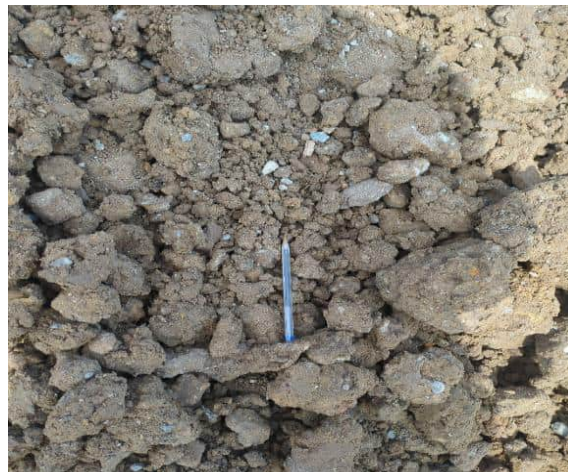
Photograph 2: Silty Clay used

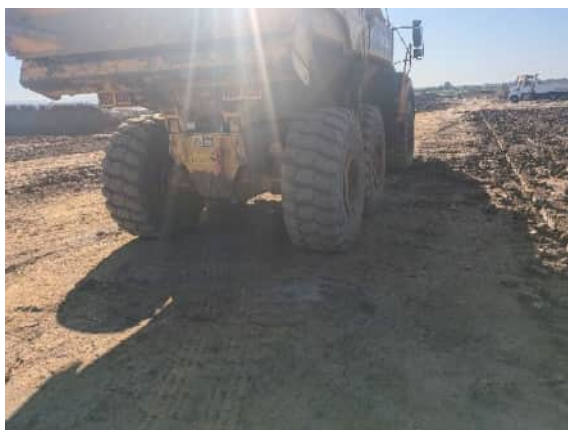
The subgrade inspection was performed in accordance with the Level 1 guidelines presented in AS 3798–2007 Section 5.5. No soft spots or deflections were encountered during the inspections and the area was found to be firm and free of vegetation and other deleterious material.

Photograph 3: Subgrade assessed with dump truck

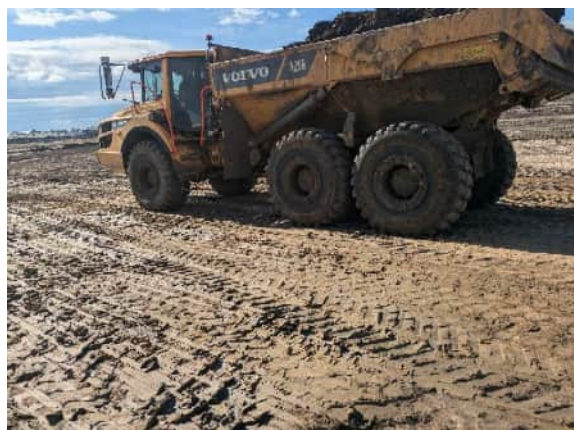
Photograph 4: Subgrade assessment using loaded dump truck

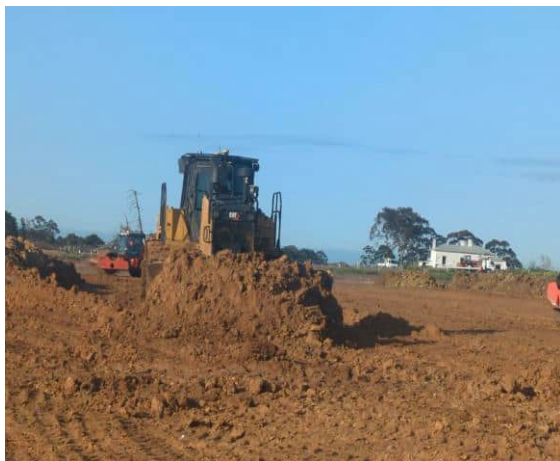
All fill material was brought by dump trucks from the local stockpiles, spread with a bulldozer and compacted with a pad foot roller. A water cart was present onsite during the works for moisture conditioning of the materials.

Photograph 5: Dozer used during fill construction

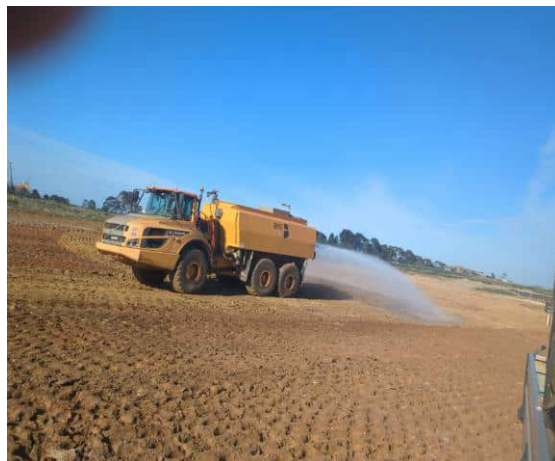
Photograph 6: Water cart used during fill construction

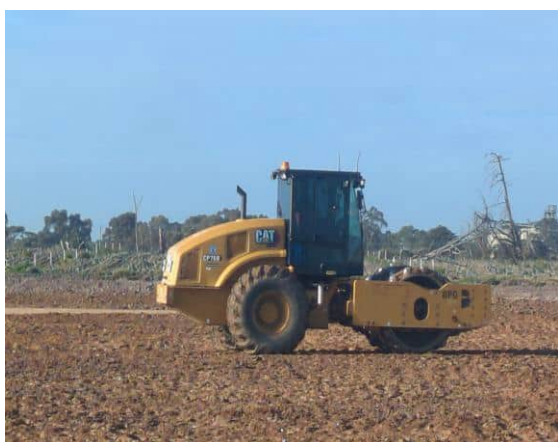
Photograph 7: Compactor used during fill construction

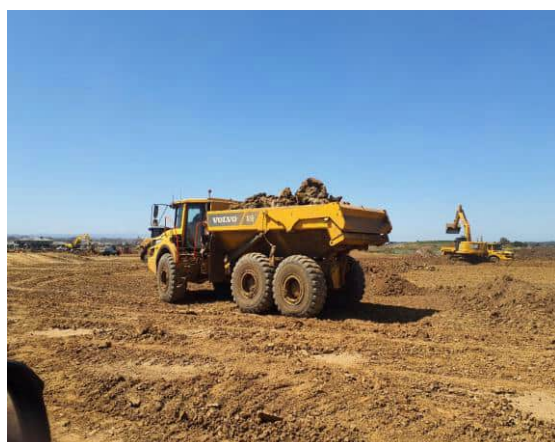
Photograph 8: Moxy trucks used during fill construction

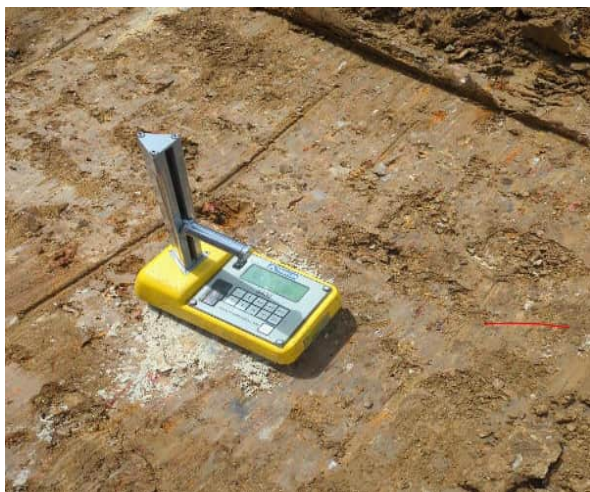
Field density and moisture content testing was undertaken progressively during the construction on the compacted fill using a calibrated portable density and moisture gauge in accordance with AS 1289.5.8.1. The HILF rapid compaction test was used for peak converted wet density determinations in accordance with AS 1289.5.7.1. Test locations were recorded using a handheld GPS unit. A site plan showing the field density test locations is provided in **Appendix A**.

Sixty-one (61) tests were performed during the filling process. Two (2) of the tests did not achieve the required density and or moisture ratio initially. The failed areas were reworked and retested accordingly. The retests returned passing density and moisture test results.

Photo 9: Field density/moisture test

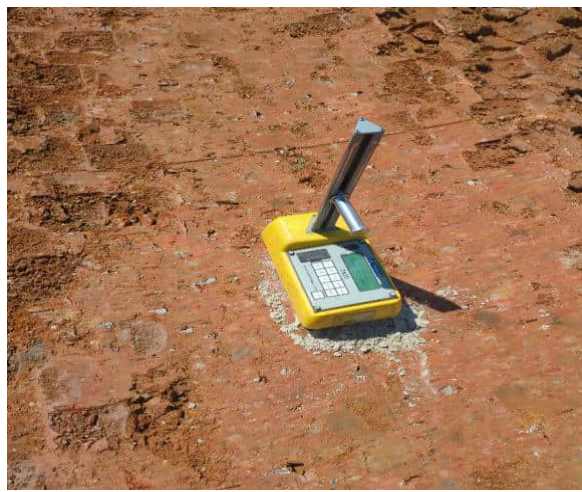
Photo 10: Field density/moisture test
