# **REPORT**

## **Level 1 Geotechnical Inspection and Testing Authority Services**

**Riverfield Square Estate Stage 25  
Lots 2501 to 2529**

**Our Ref: 1091938.025.R1.v1**

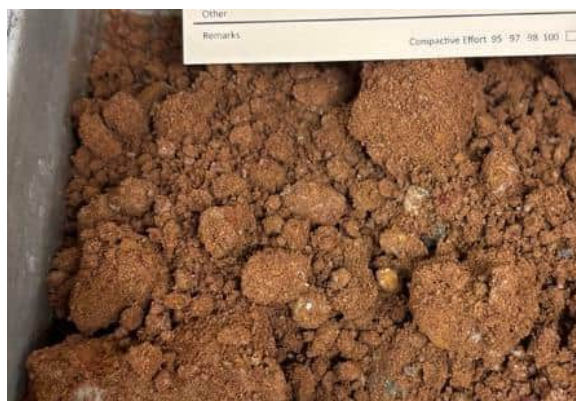
Material used for the construction of the fill comprised of local gravelly and silty clays won from the road boxing and trench excavations on this and the surrounding sites.

The laboratory test results indicated material is clay of medium plasticity and satisfied the requirements of the Specification.

*Photograph 1: Typical clay material used on site*

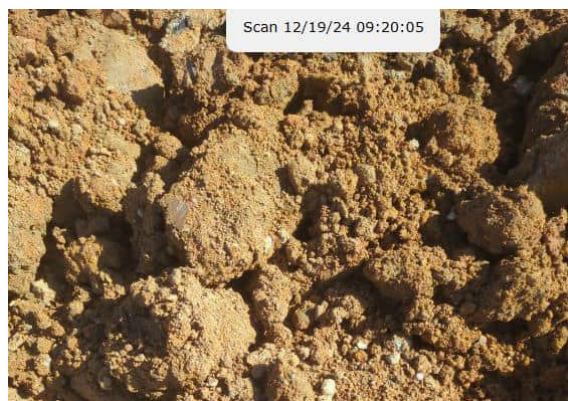
*Photograph 2: Silty Clay used*

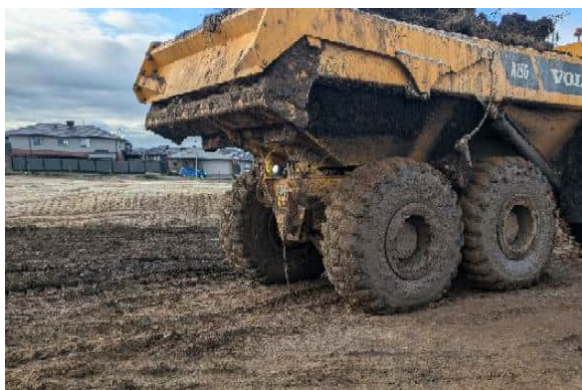
The subgrade inspection was performed in accordance with the Level 1 guidelines presented in AS 3798–2007 Section 5.5. No soft spots or deflections were encountered during the inspections and the area was found to be firm and free of vegetation and other deleterious material.

*Photograph 3: Subgrade assessed with dump truck*

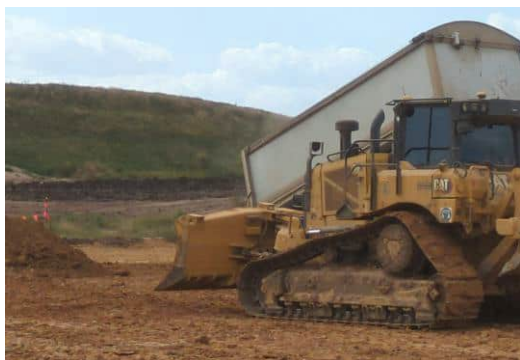
All fill material was brought by dump trucks from the local stockpiles, spread with a bulldozer and compacted with a pad foot roller. A water cart was present onsite during the works for moisture conditioning of the materials.

*Photograph 5: Dozer used during fill construction*

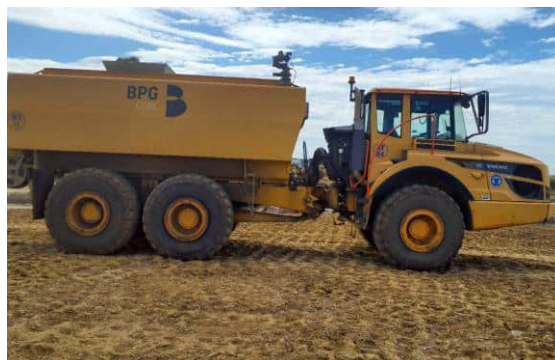
*Photograph 6: Water cart used during fill construction*

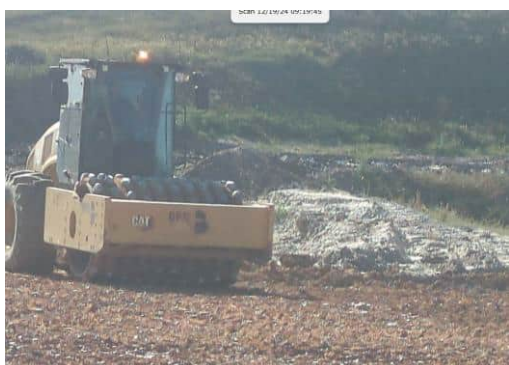
*Photograph 7: Compactor used during fill construction*

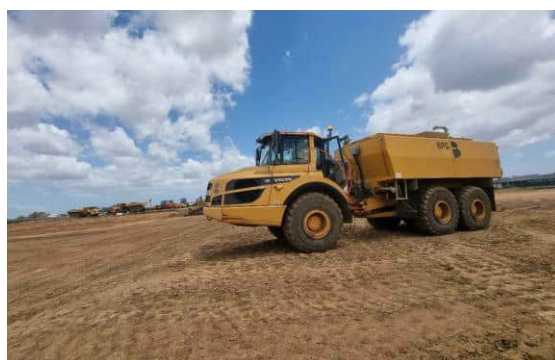
*Photograph 8: Moxy trucks used during fill construction*

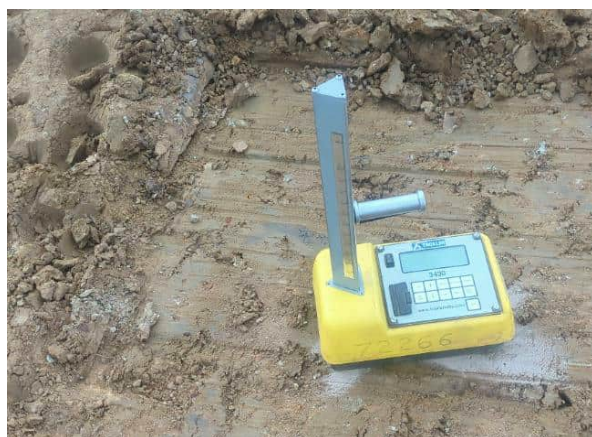
Field density and moisture content testing was undertaken progressively during the construction on the compacted fill using a calibrated portable density and moisture gauge in accordance with AS 1289.5.8.1. The HILF rapid compaction test was used for peak converted wet density determinations in accordance with AS 1289.5.7.1. Test locations were recorded using a handheld GPS unit. A site plan showing the field density test locations is provided in **Appendix A**.

*Photo 9: Field density/moisture test*

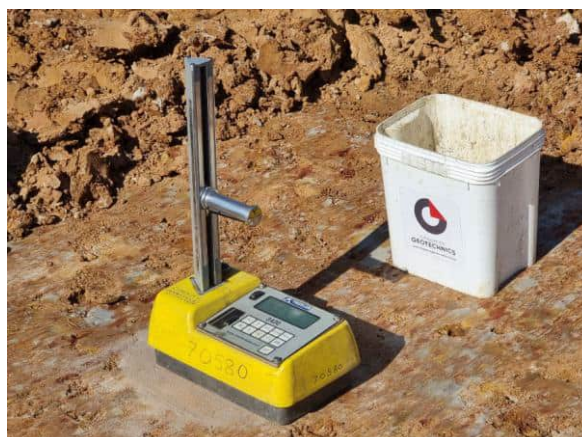
*Photo 10: Field density/moisture test*
