# REPORT

## **Level 1 Geotechnical Inspection and Testing Authority Services**

**Riverfield Square Estate Stage 32  
Lots 3203 to 3234**

**28.11.2025**  
Our Ref: 1091938.032.v1

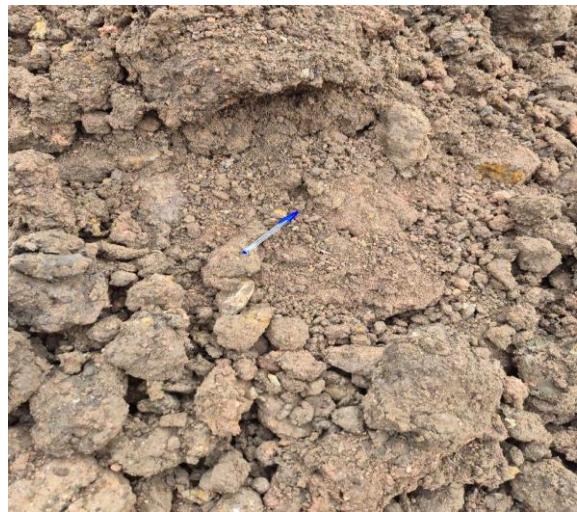
The laboratory test results indicate the fill materials are a CLAYS/Sandy CLAY of high plasticity and clayey SAND of low plasticity and satisfied the requirements of the specification.

*Photograph 2: Sandy Clay used*

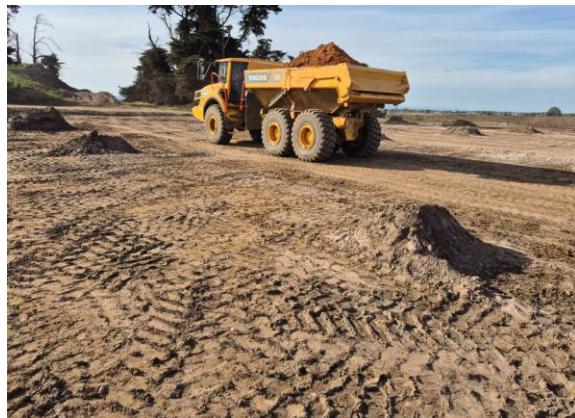
#### Photograph 4.2: Subgrade assessment photographs

The subgrade inspection was performed in accordance with the Level 1 guidelines presented in AS3798–2007 Section 5.5. No soft spots or deflections were encountered during the inspections, and the area was found to be firm and free of vegetation and other deleterious material.

Photograph 3: Subgrade assessed with dump truck

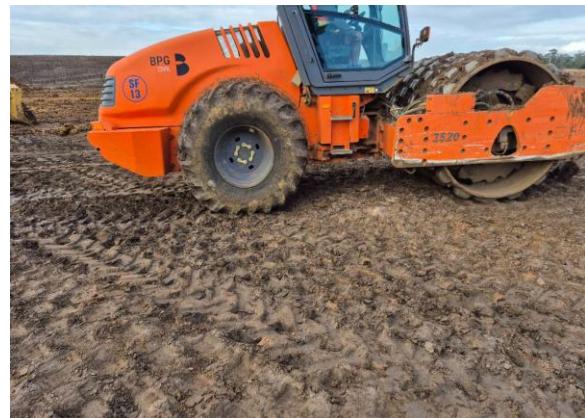
Photograph 4: Subgrade assessment using pad foot roller

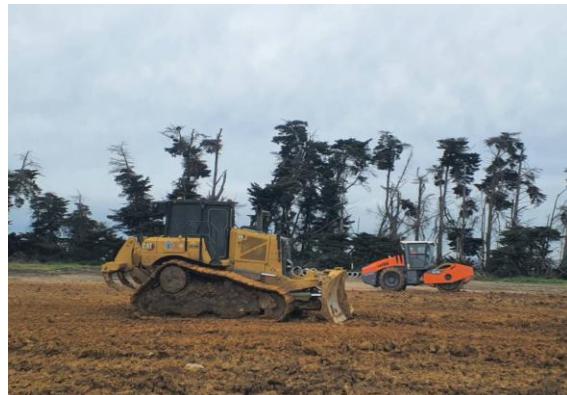
**Photograph 4.3: General Earthwork machinery and fill construction photographs**

All fill material was brought by dump trucks from the local stockpiles, spread with a bulldozer and compacted with a pad foot roller. A water cart was present onsite during the works for moisture conditioning of the materials.

*Photograph 5: Dozer used during fill construction*

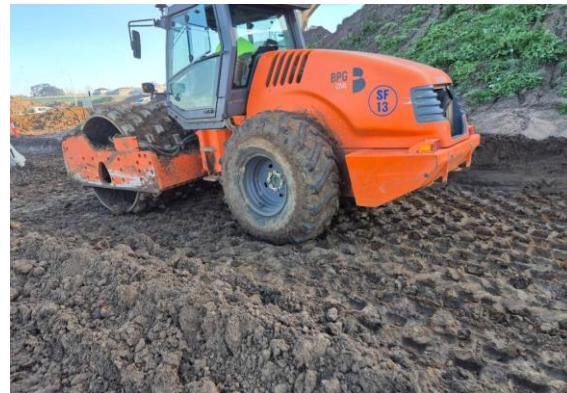
*Photograph 6: Pad foot roller used during fill construction*

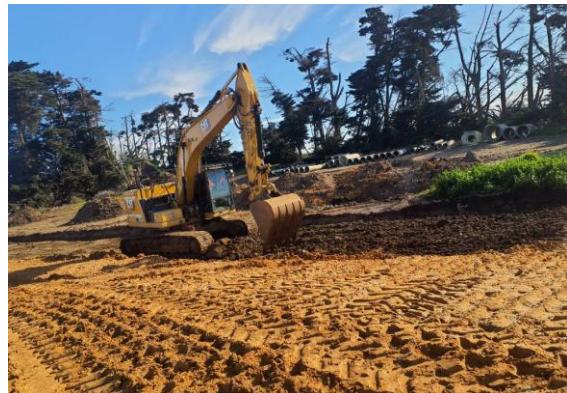
*Photograph 7: Excavator during fill construction*

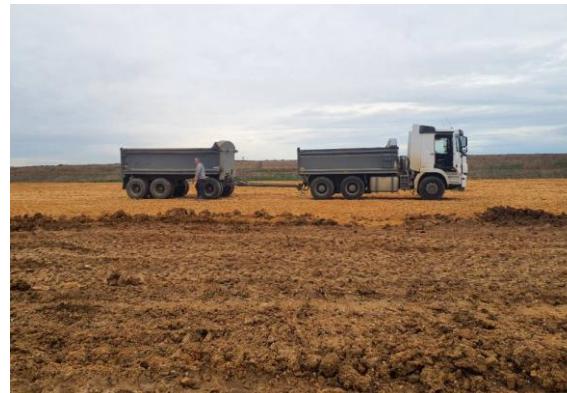
*Photograph 8: Truck and trailer used during fill construction*

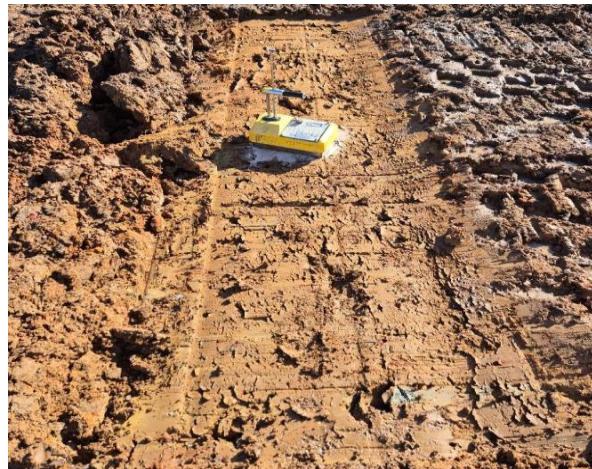
### Photograph 4.4: Field Density/Moisture Testing photographs

Field density and moisture content testing was undertaken progressively during the construction on the compacted fill using a calibrated portable density and moisture gauge in accordance with AS 1289.5.8.1. The HILF rapid compaction test was used for peak converted wet density determinations in accordance with AS1289.5.7.1. Test locations were recorded using a handheld GPS unit. A site plan showing the field density test locations is provided in **Appendix A**.

Thirty-five (35) tests were performed during the filling process. Two (2) of the tests did not achieve the required moisture ratio initially. The failed areas were reworked and retested accordingly. The retests returned passing density and moisture test results.

*Photo 9: Field density/moisture test*

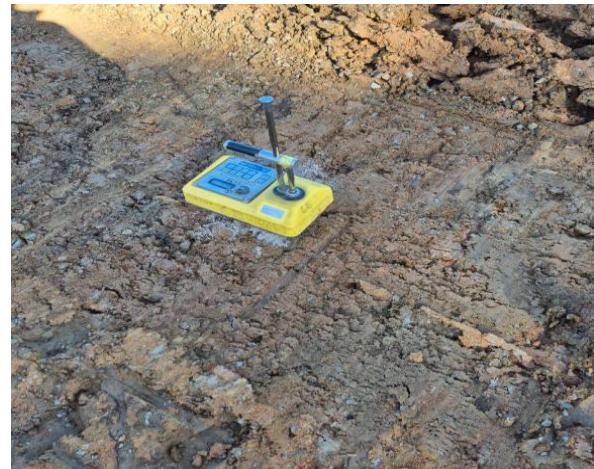
*Photo 10: Field density/moisture test*
